memorandum

subject Hamilton Wetlands Post-Construction As-Built Survey Review – Breach and Completion Contract.

This memorandum presents the ESA's post-construction assessment of the Hamilton Wetland Restoration Project following the Breach and Completion Contract.

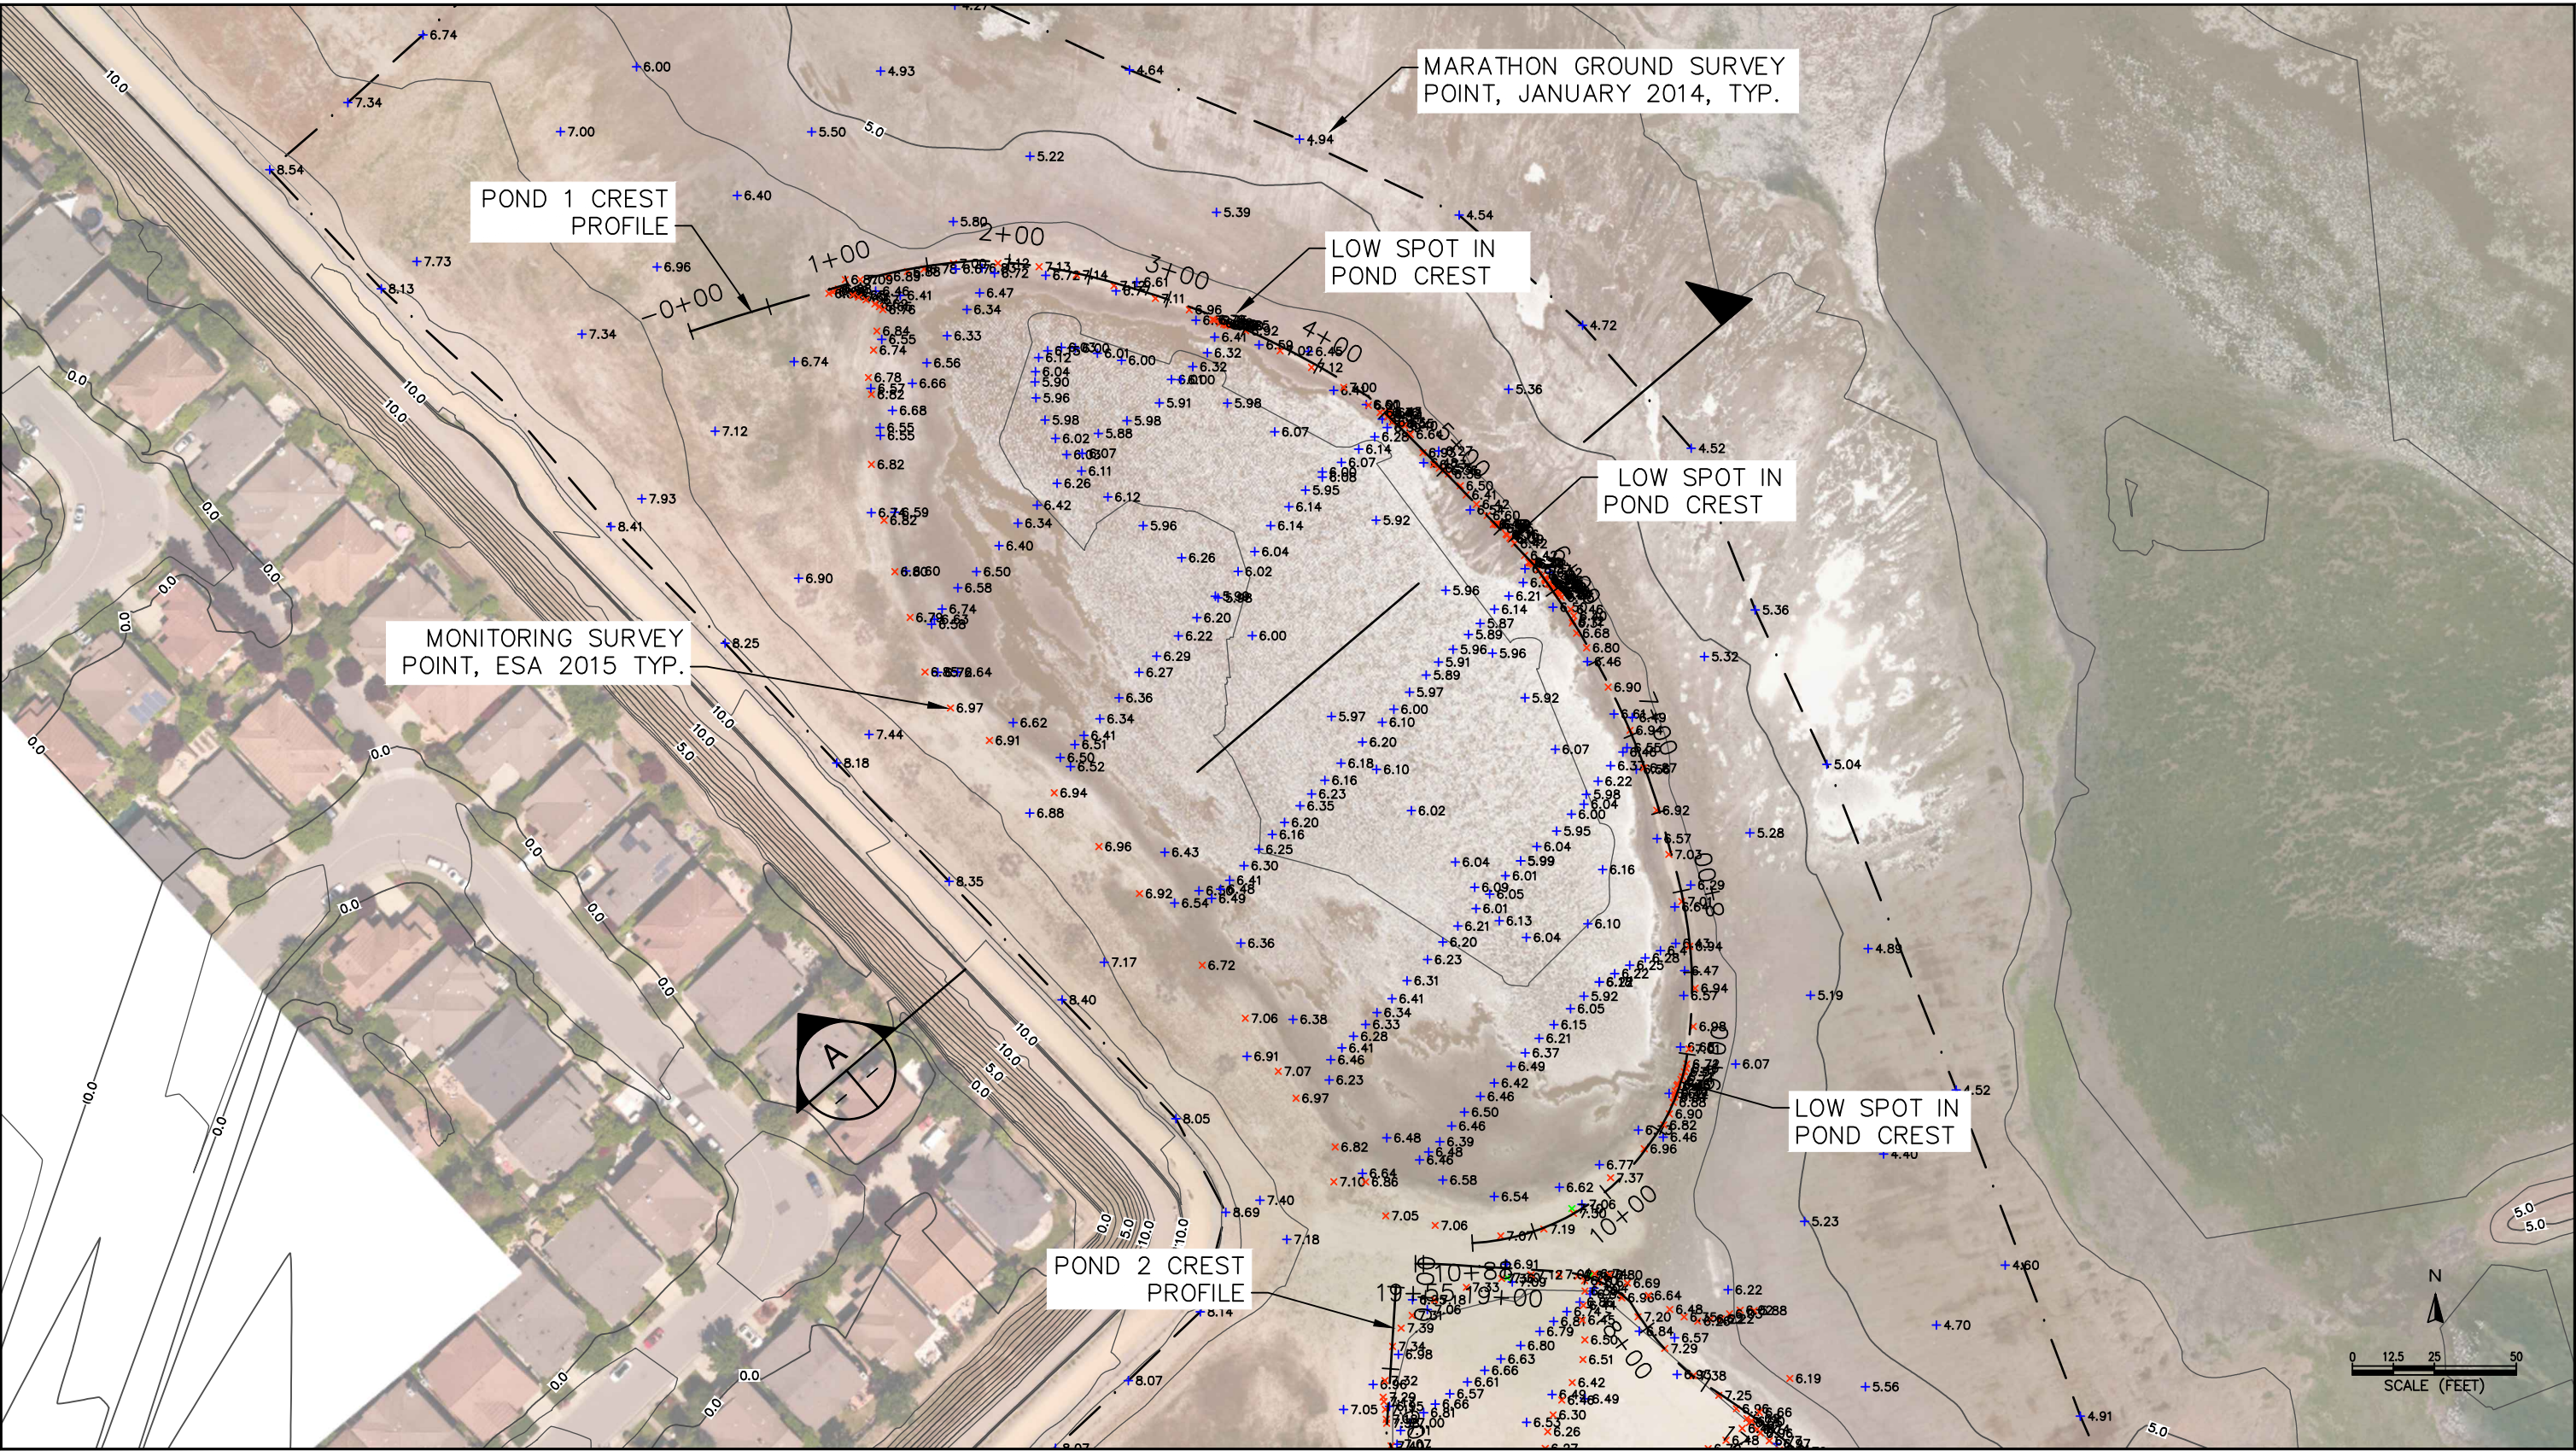
Hamilton Post-Construction Assessment
FIGURE 2
As-Built Surveys - SSW Pond 1

Figures 2 through 5 show the as-built survey data for the various SSW ponds including points collected by Marathon post construction, Aerial photogrammetry, and points surveyed by ESA around the pond crest. Figure 6 shows the difference between the design grade and the post-construction aerial photogrammetry, and Figure 7 shows the difference between the design grade and the post-construction ground survey. Figure 6 highlights significant areas of the SSW marshplain and ponds generally below design grades beyond the design tolerance. Figure 7 shows a smaller extent of out-of-tolerance elevations, but still shows many areas significantly outside of the ± 0.5 ft design tolerance.

The bed elevations of all ponds meet the design tolerance. While no specific design tolerance was specified for pond area, the areas of all ponds except Pond 1 were found to be generally comparable to the areas indicated in the design. Pond 1 was found to be 20,000 SF smaller than design, a ~15% reduction in area.

- Place compacted fill around the perimeter of each pond to achieve design sill elevations.
 - Plant mid and high marsh plantings (as appropriate) along the entire length of each sill around the perimeter of each pond to help establish a dense cover of vegetation to limit erosion.

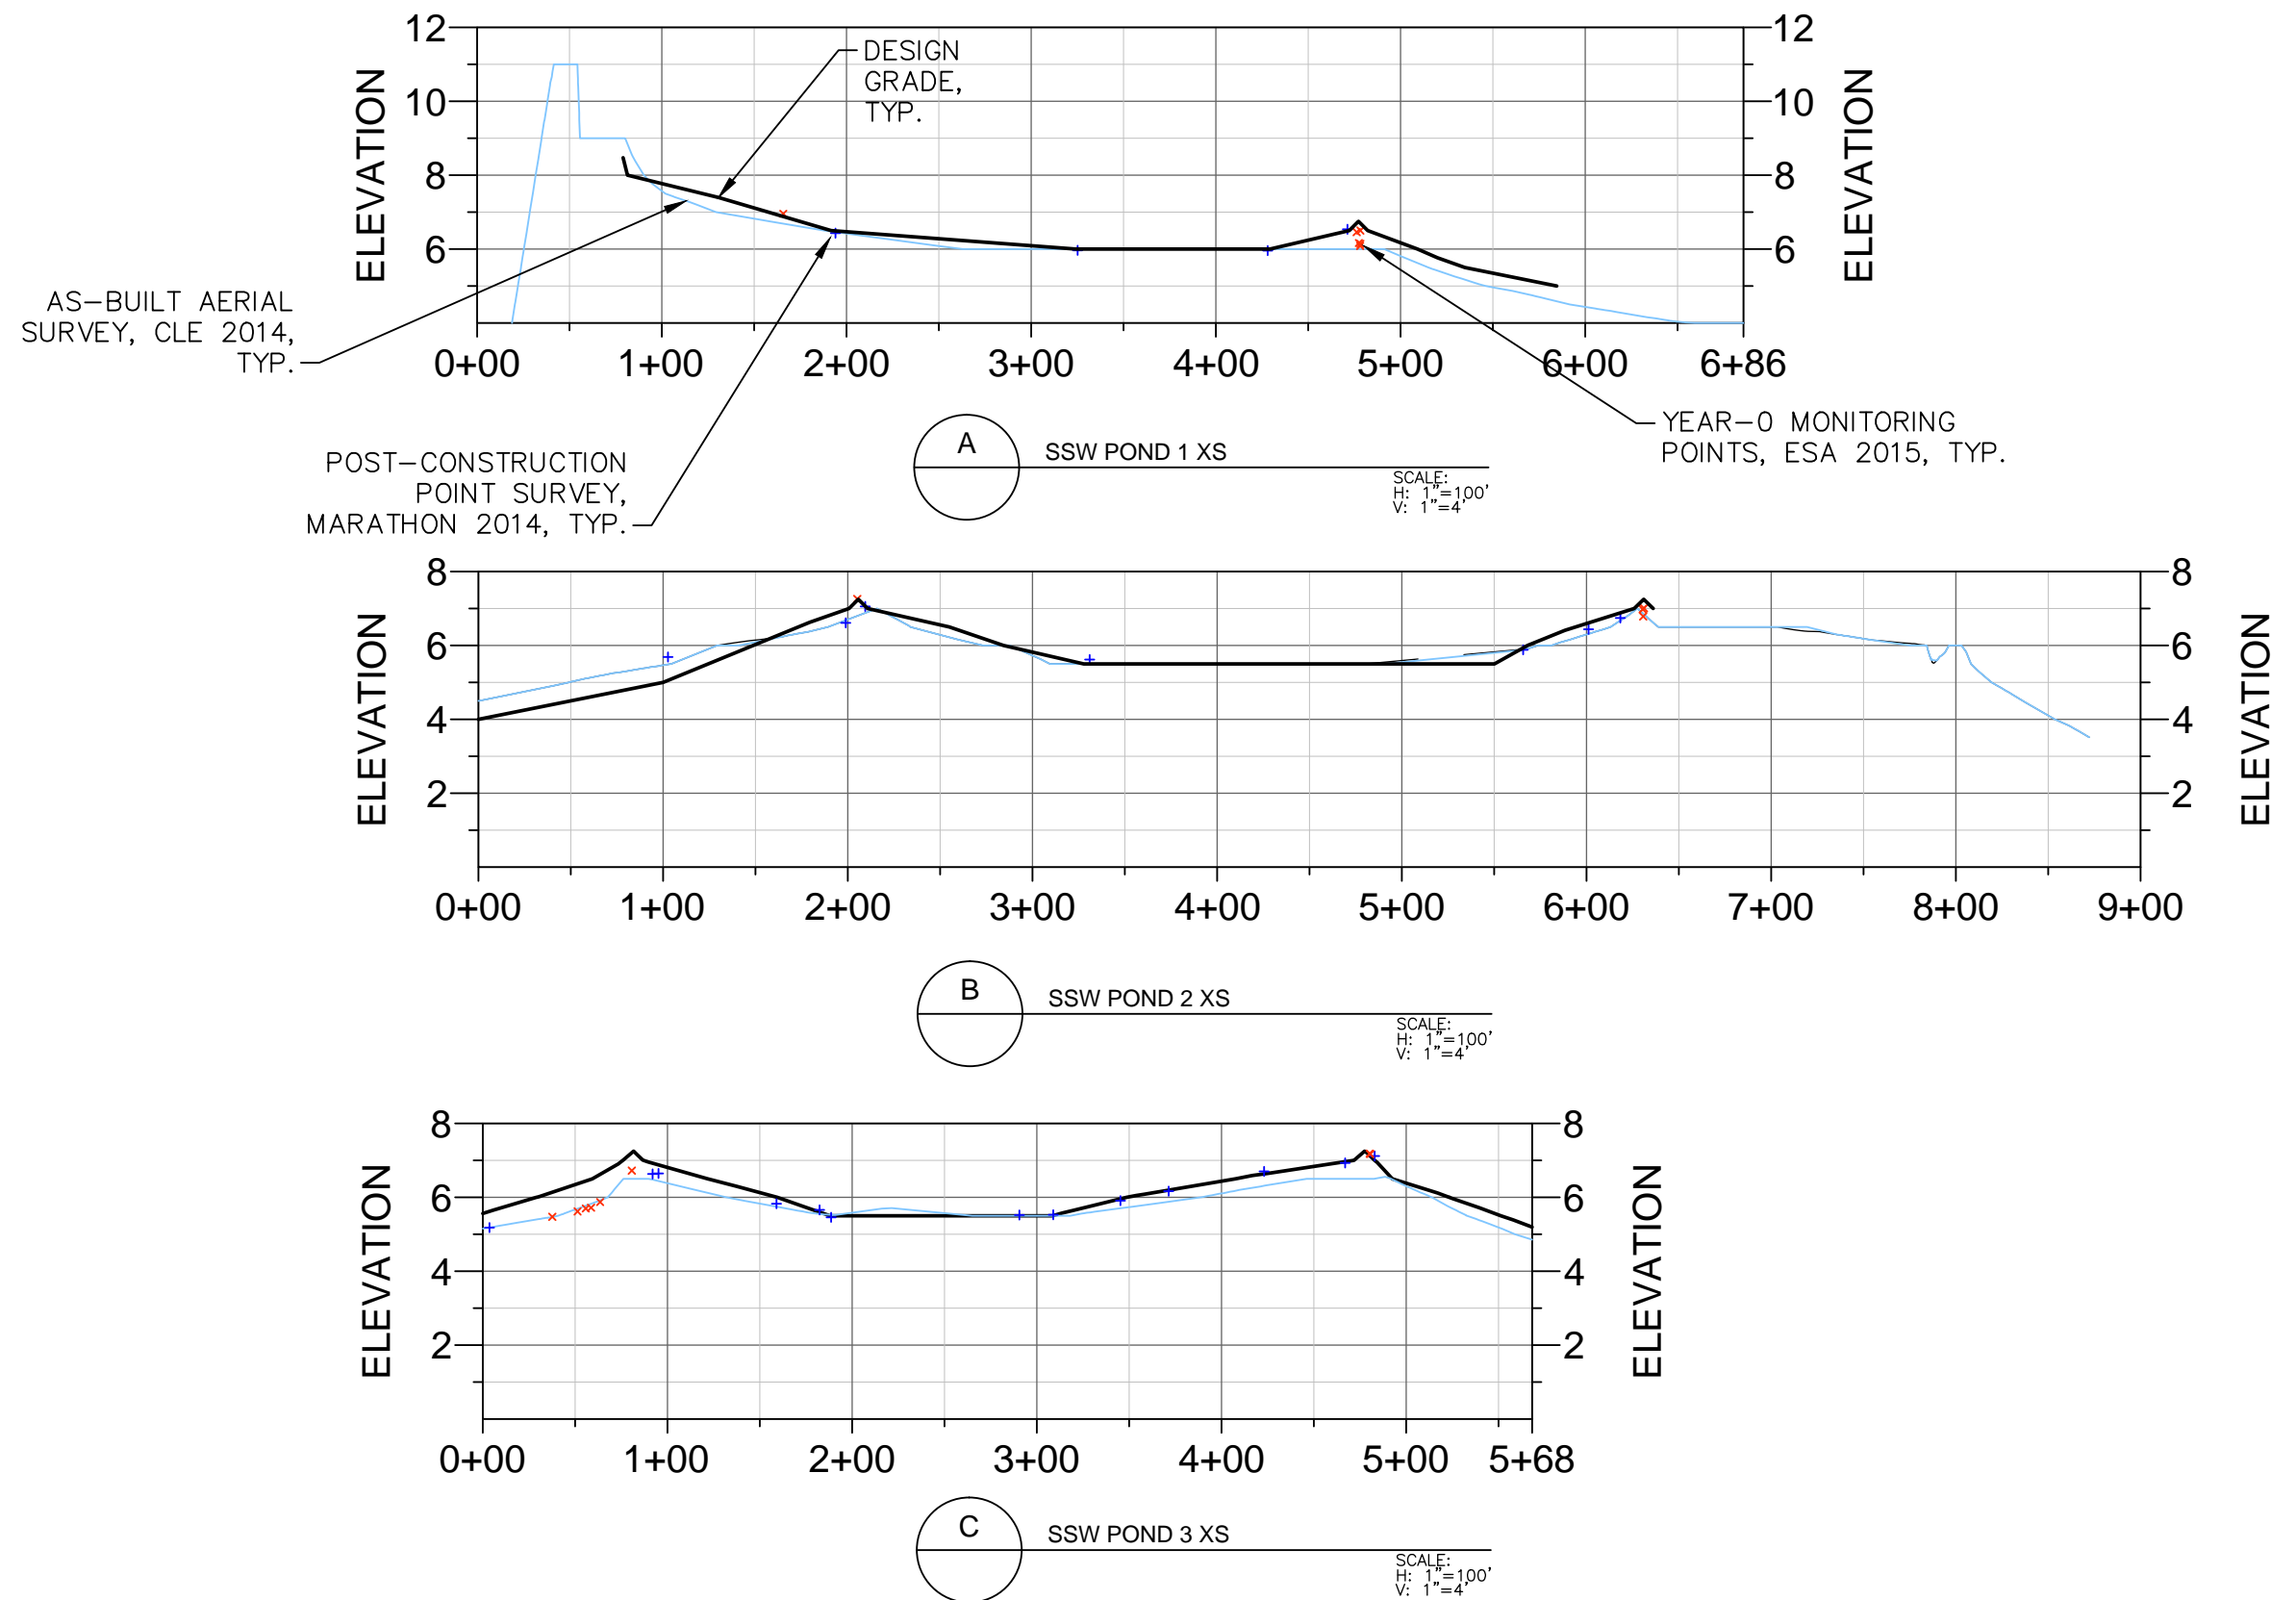
FIGURE 8

Figures 8 and 9 show cross sections cut through the 5 ponds, and Figures 10 and 11 show profiles taken along the pond crests comparing design and surveyed grades. The post construction aerial photogrammetric survey cross-sections generally plot below design grades, while the post construction point survey (collected soon after completion) are closer to design grades. In general, the as-built pond sill elevations were lower than specified in the design, with portions of all 5 pond crests found to have elevations lower than allowed by the design tolerance. In some locations, erosion has lowered portions of the sill up to 1 foot below design grade as shown in the profiles (ESA 2015 surveys). Crest elevations below design grades subject the ponds to increased tidal exchange and increase drainage during low tides, reducing the habitat value of these areas and increasing the likelihood of erosion. Observations made during the Year-0 monitoring effort note that Pond 1 drains almost completely during low tides due to the emergence of small erosional channels through the pond crest.

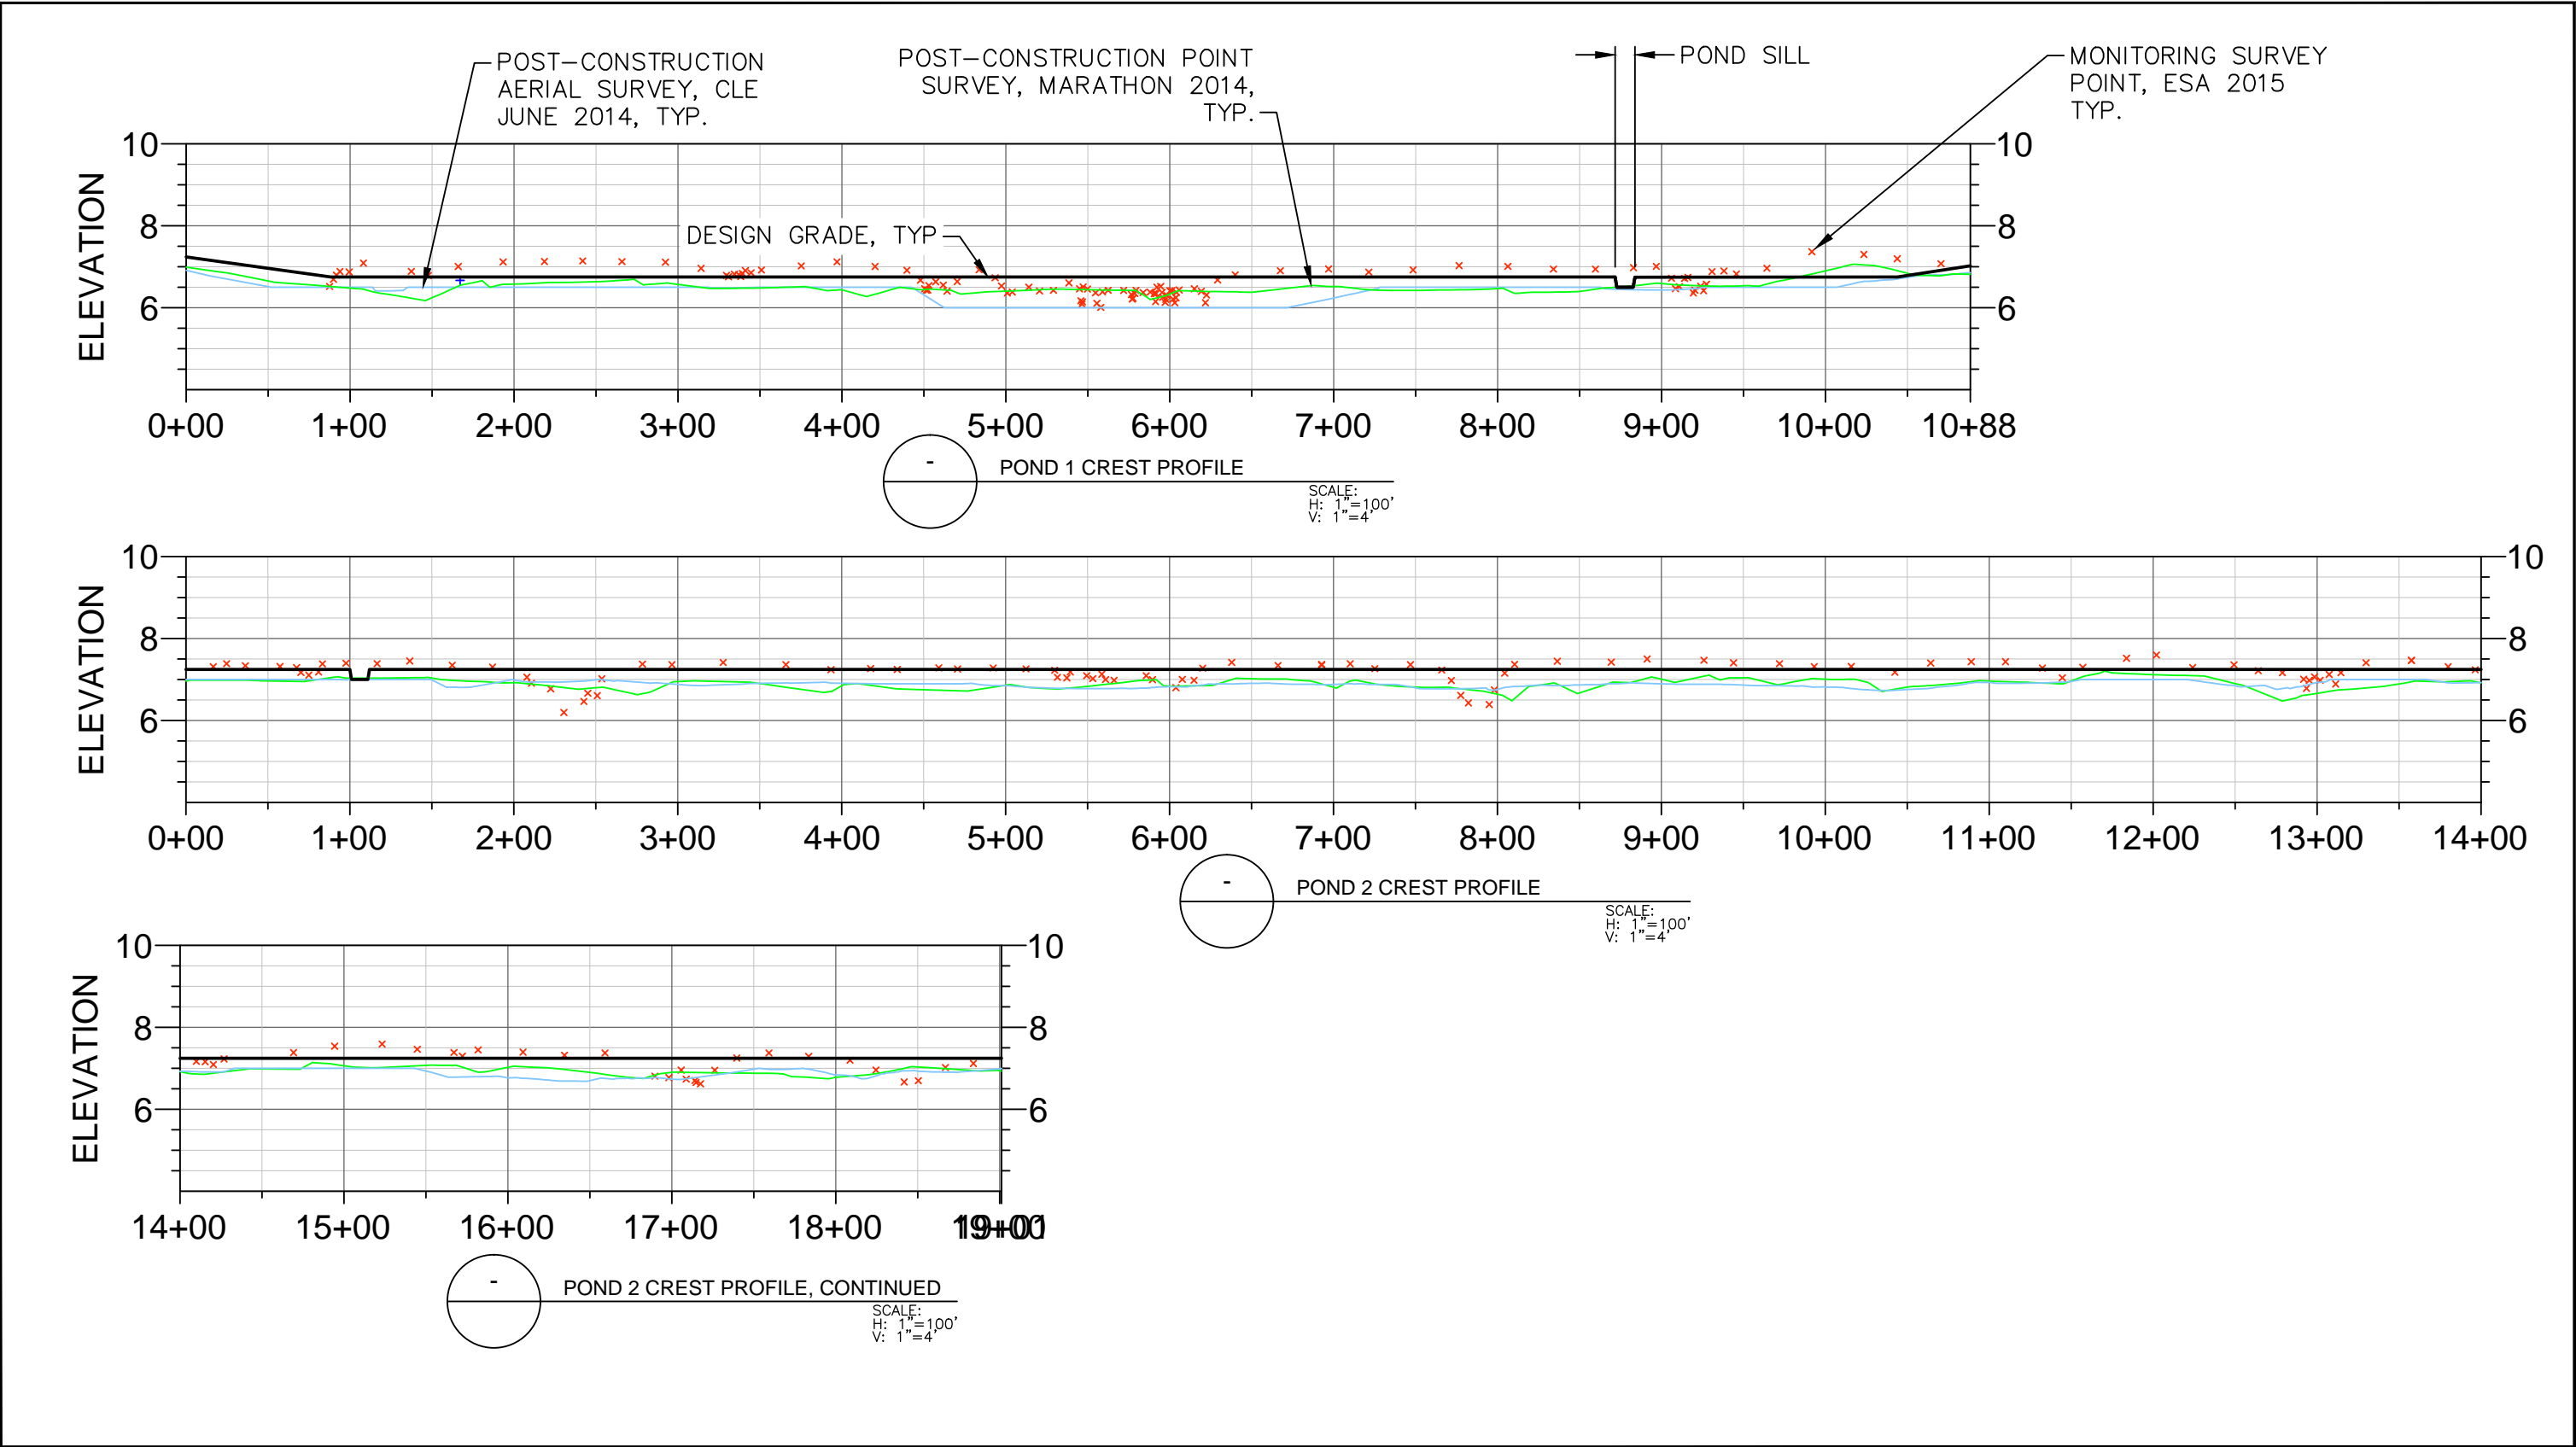
FIGURE 10

- *The South Seasonal Wetland Pond perimeter sill elevations are too low:* The perimeter sill elevations of all five South Seasonal Wetland Ponds are lower than specified in the design. These sills were intended to limit overtopping into the ponds, creating intermittently inundated habitat areas and reducing the likelihood of scour. The design included a compacted sill (compacted to 95% R.C.) to guide tidal flows into and out of each pond. However, with numerous erosional cuts through the lower perimeter elevations will allow for more frequent inundation and provide flow paths which appear to be encouraging channel growth near or in the ponds, limiting the desired habitat from establishing. The sill erosion and channel formation at Pond 1 is particularly advanced. The formation of channels in the vicinity of the seasonal wetlands ponds is highly problematic. Channels would prevent the occurrence of ponded water, reducing the habitat value for wading birds. Furthermore, eroding channels could allow tidal channels to form potentially scouring into the clean cover material over the low-level DDT contaminated soils, violating the project permit requirements and possibly allowing contaminants to mobilize from the ponds.

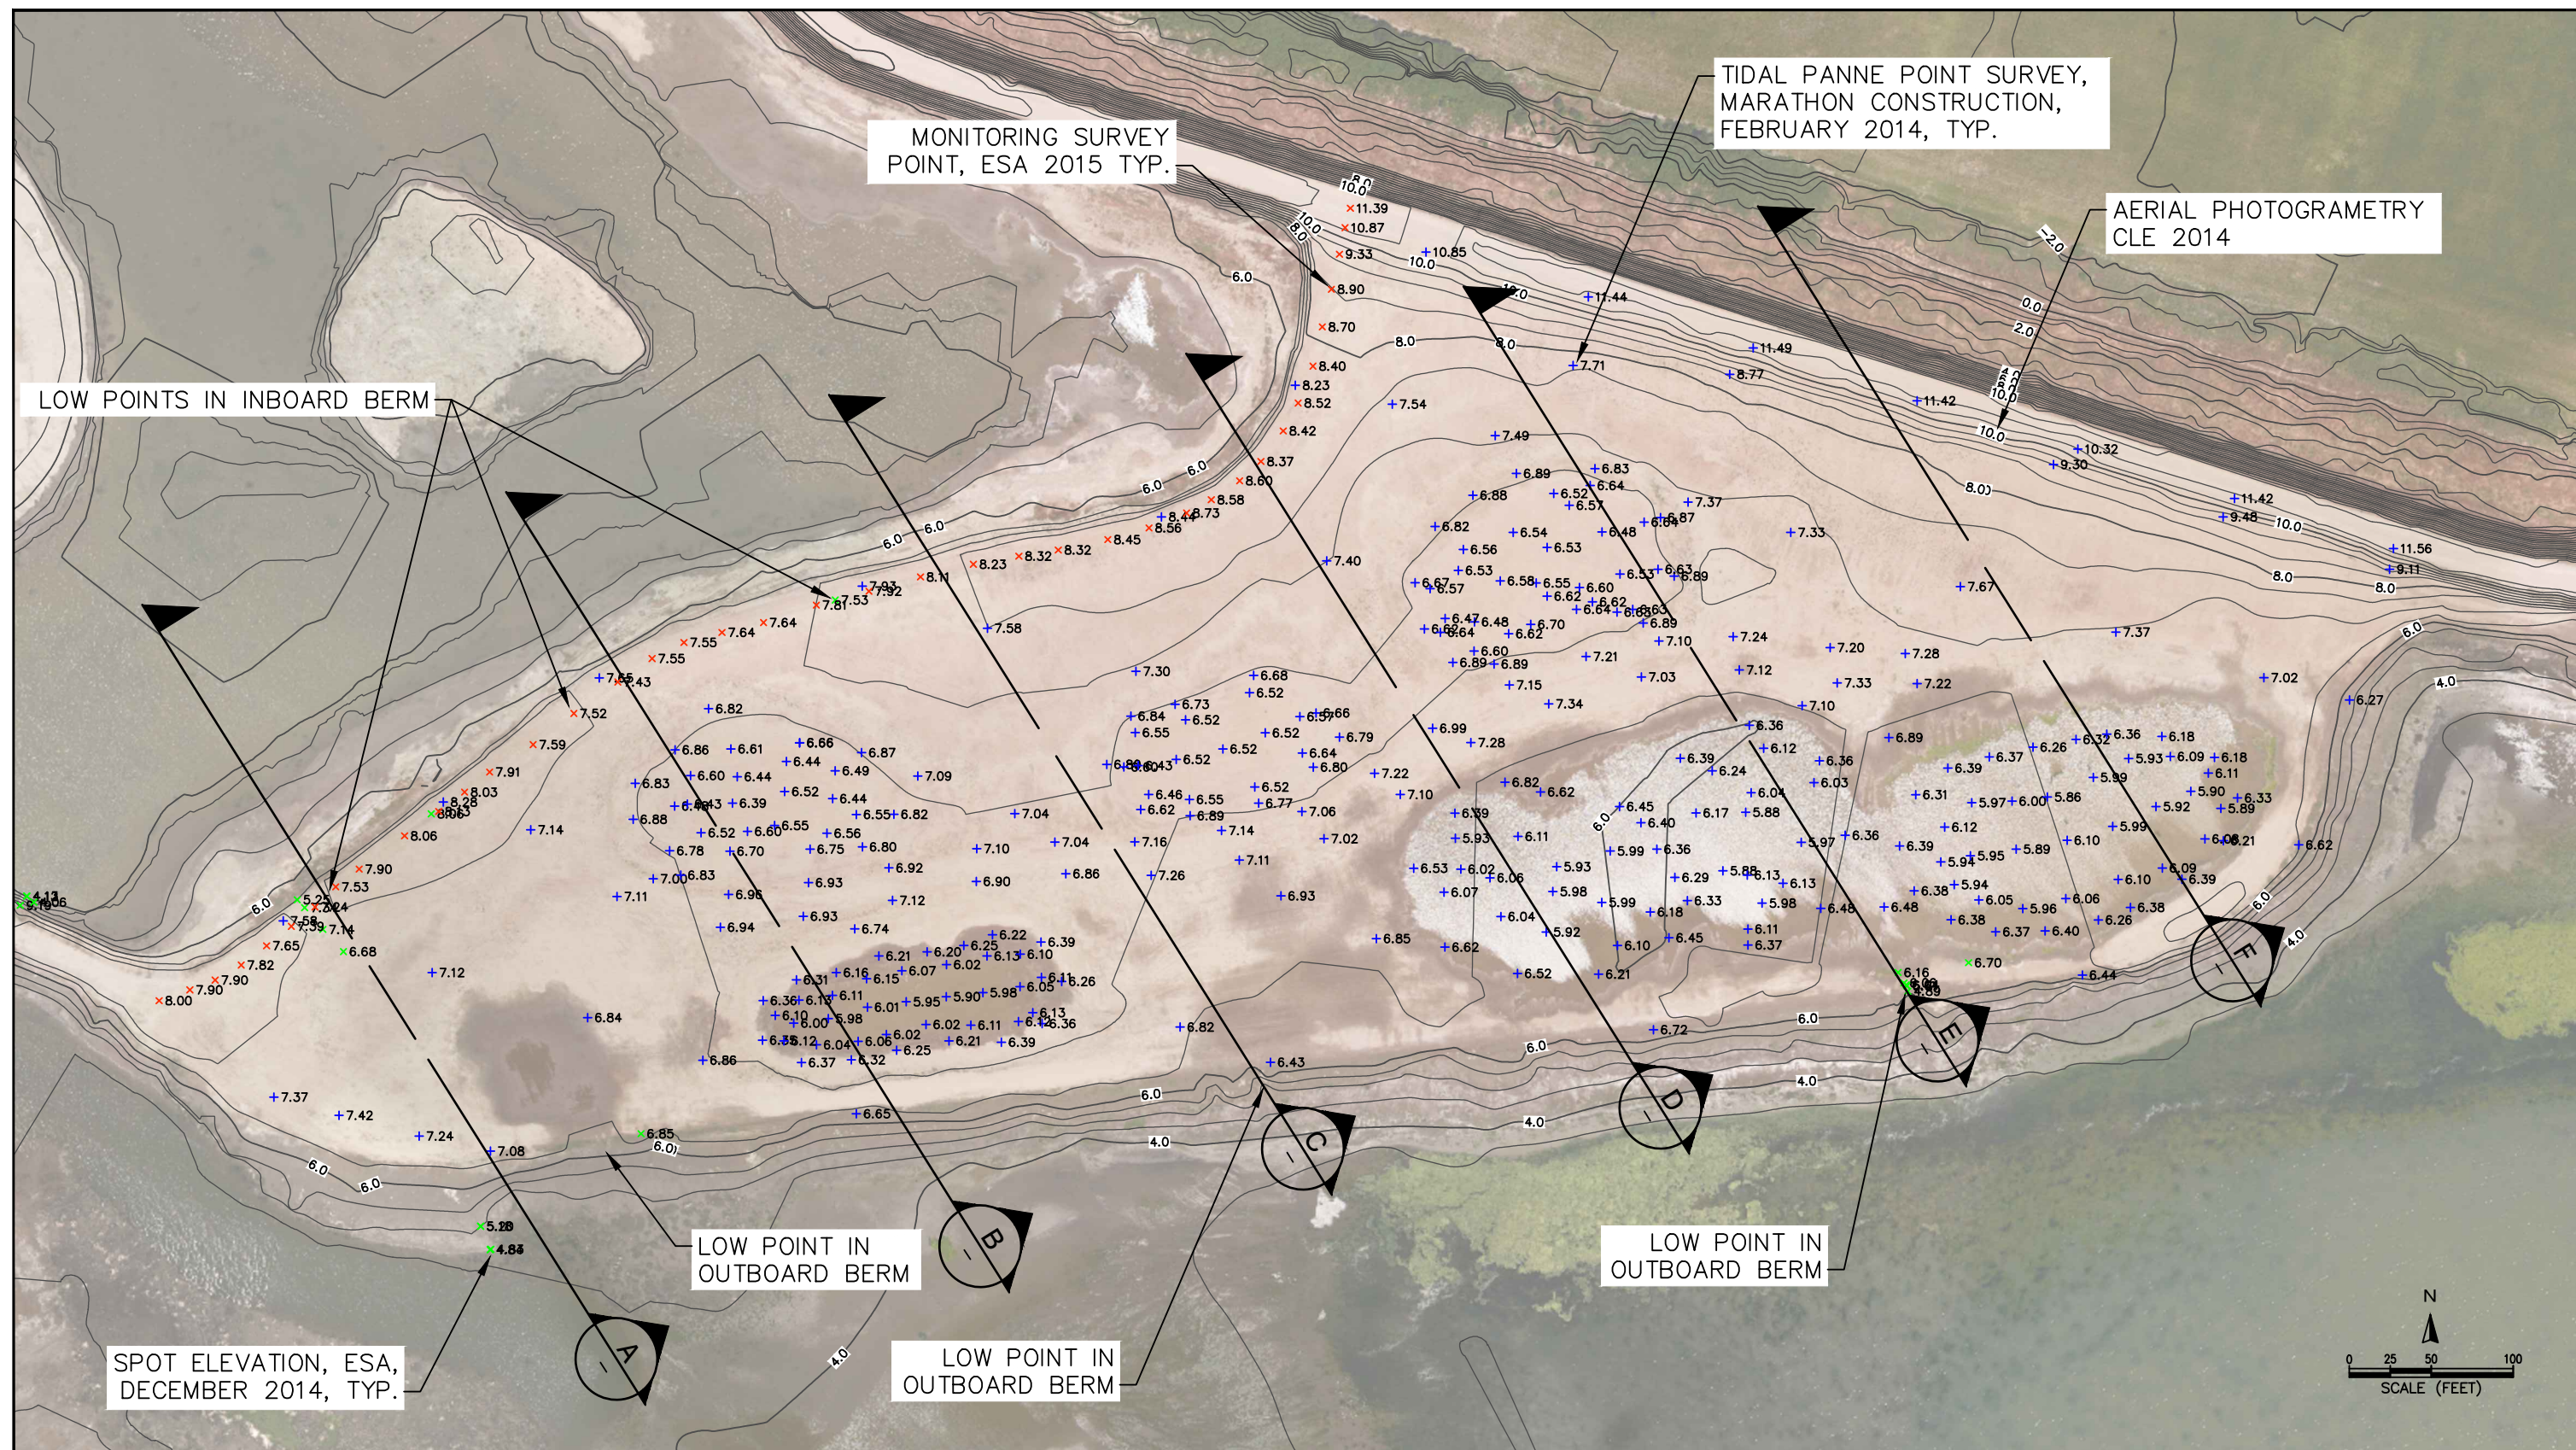
FIGURE 12

Figure 12 shows the as-built surveys for the Tidal Pannes including contours from the aerial photogrammetry, spot elevations collected post construction, and spot elevations along the NSW berm collected by ESA. Figure 13 shows the difference between the design grade and the post-construction ground survey. Figure 14 shows the difference between the design grade and the post-construction aerial photogrammetry. Figure 15 shows typical cross sections of the Tidal Pannes. Note that the point survey data show close agreement to the design grades, while the aerial photogrammetry survey shows larger deviations from the design grade.

There are three sills located at the Tidal Pannes which define the edges of the pannes and separate the Tidal Pannes from the outboard marsh and the inboard North Seasonal Wetlands. The design grade of the outboard sill is 6.5' NAVD. The CLE aerial survey shows the post-construction grade using 0.5' contour intervals, which does not provide sufficient detail to determine whether the sill elevation meets the +/-0.15' design tolerance. The point survey data collected by Marathon Construction includes several points taken at 200'-300' intervals along the outboard sill. The elevations of these points range from 6.27' to 7.08' NAVD. The low end of this range is below the design tolerance, while the high end is 0.58' above design grade and significantly beyond the 0.15' tolerance.

In December 2014, approximately 10 months after the Marathon survey, ESA staff walked the length of the outboard sill during a low tide and observed several locations where low points in the sill were allowing water to drain from the pannes and showed signs of erosion leading to tidal channel formation. ESA collected spot elevations at the lowest erosional channel, finding the eroded channel at 6.16' NAVD, which is 0.34' below design grade. This eroded channel will limit the depth of ponding in the lower tidal pannes. As these channels continue to incise, the lower tidal pans may not maintain ponding and function as intended.

The design grade of the middle pond sill is 7.0' NAVD. The CLE aerial survey shows a continuous flat expanse at 6.5' NAVD where this sill should be located. This may suggest that the sill elevation is lower than the design grade, but also could be due to the limitations of the surveys 0.5' contour interval. The Marathon point survey showed the sill ranging from 6.93' to 7.34' NAVD shortly following construction, with the majority of the sill appearing to be within tolerance in the post construction ground survey. This sill should be monitored to confirm that it is within tolerance and that the upper pannes will maintain ponding and function as intended.

The design grade of the lowered NSW levee, which separates the Tidal Pannes from the North Seasonal Wetlands, is 8.0' NAVD. The CLE aerial survey shows this levee between 7.5 and 8.0' NAVD. Survey points collected by ESA in January 2015 as part of the Year 0 Monitoring effort show sections of the levee as low as 7.37' NAVD, 0.48' below tolerance. Overtopping and erosion was observed during the December 2014 storms. Table 2 compares the key design dimensions of the Tidal Pannes with those measured by the as-built surveys:

- Place compacted fill along the Tidal Panne sills and the lowered NSW/Tidal Panne levee to achieve design elevations.

- Plant mid and high marsh plantings (as appropriate) along the entire length of each sill and the lowered NSW/Tidal Panne levee to help establish a dense cover of vegetation to limit erosion.

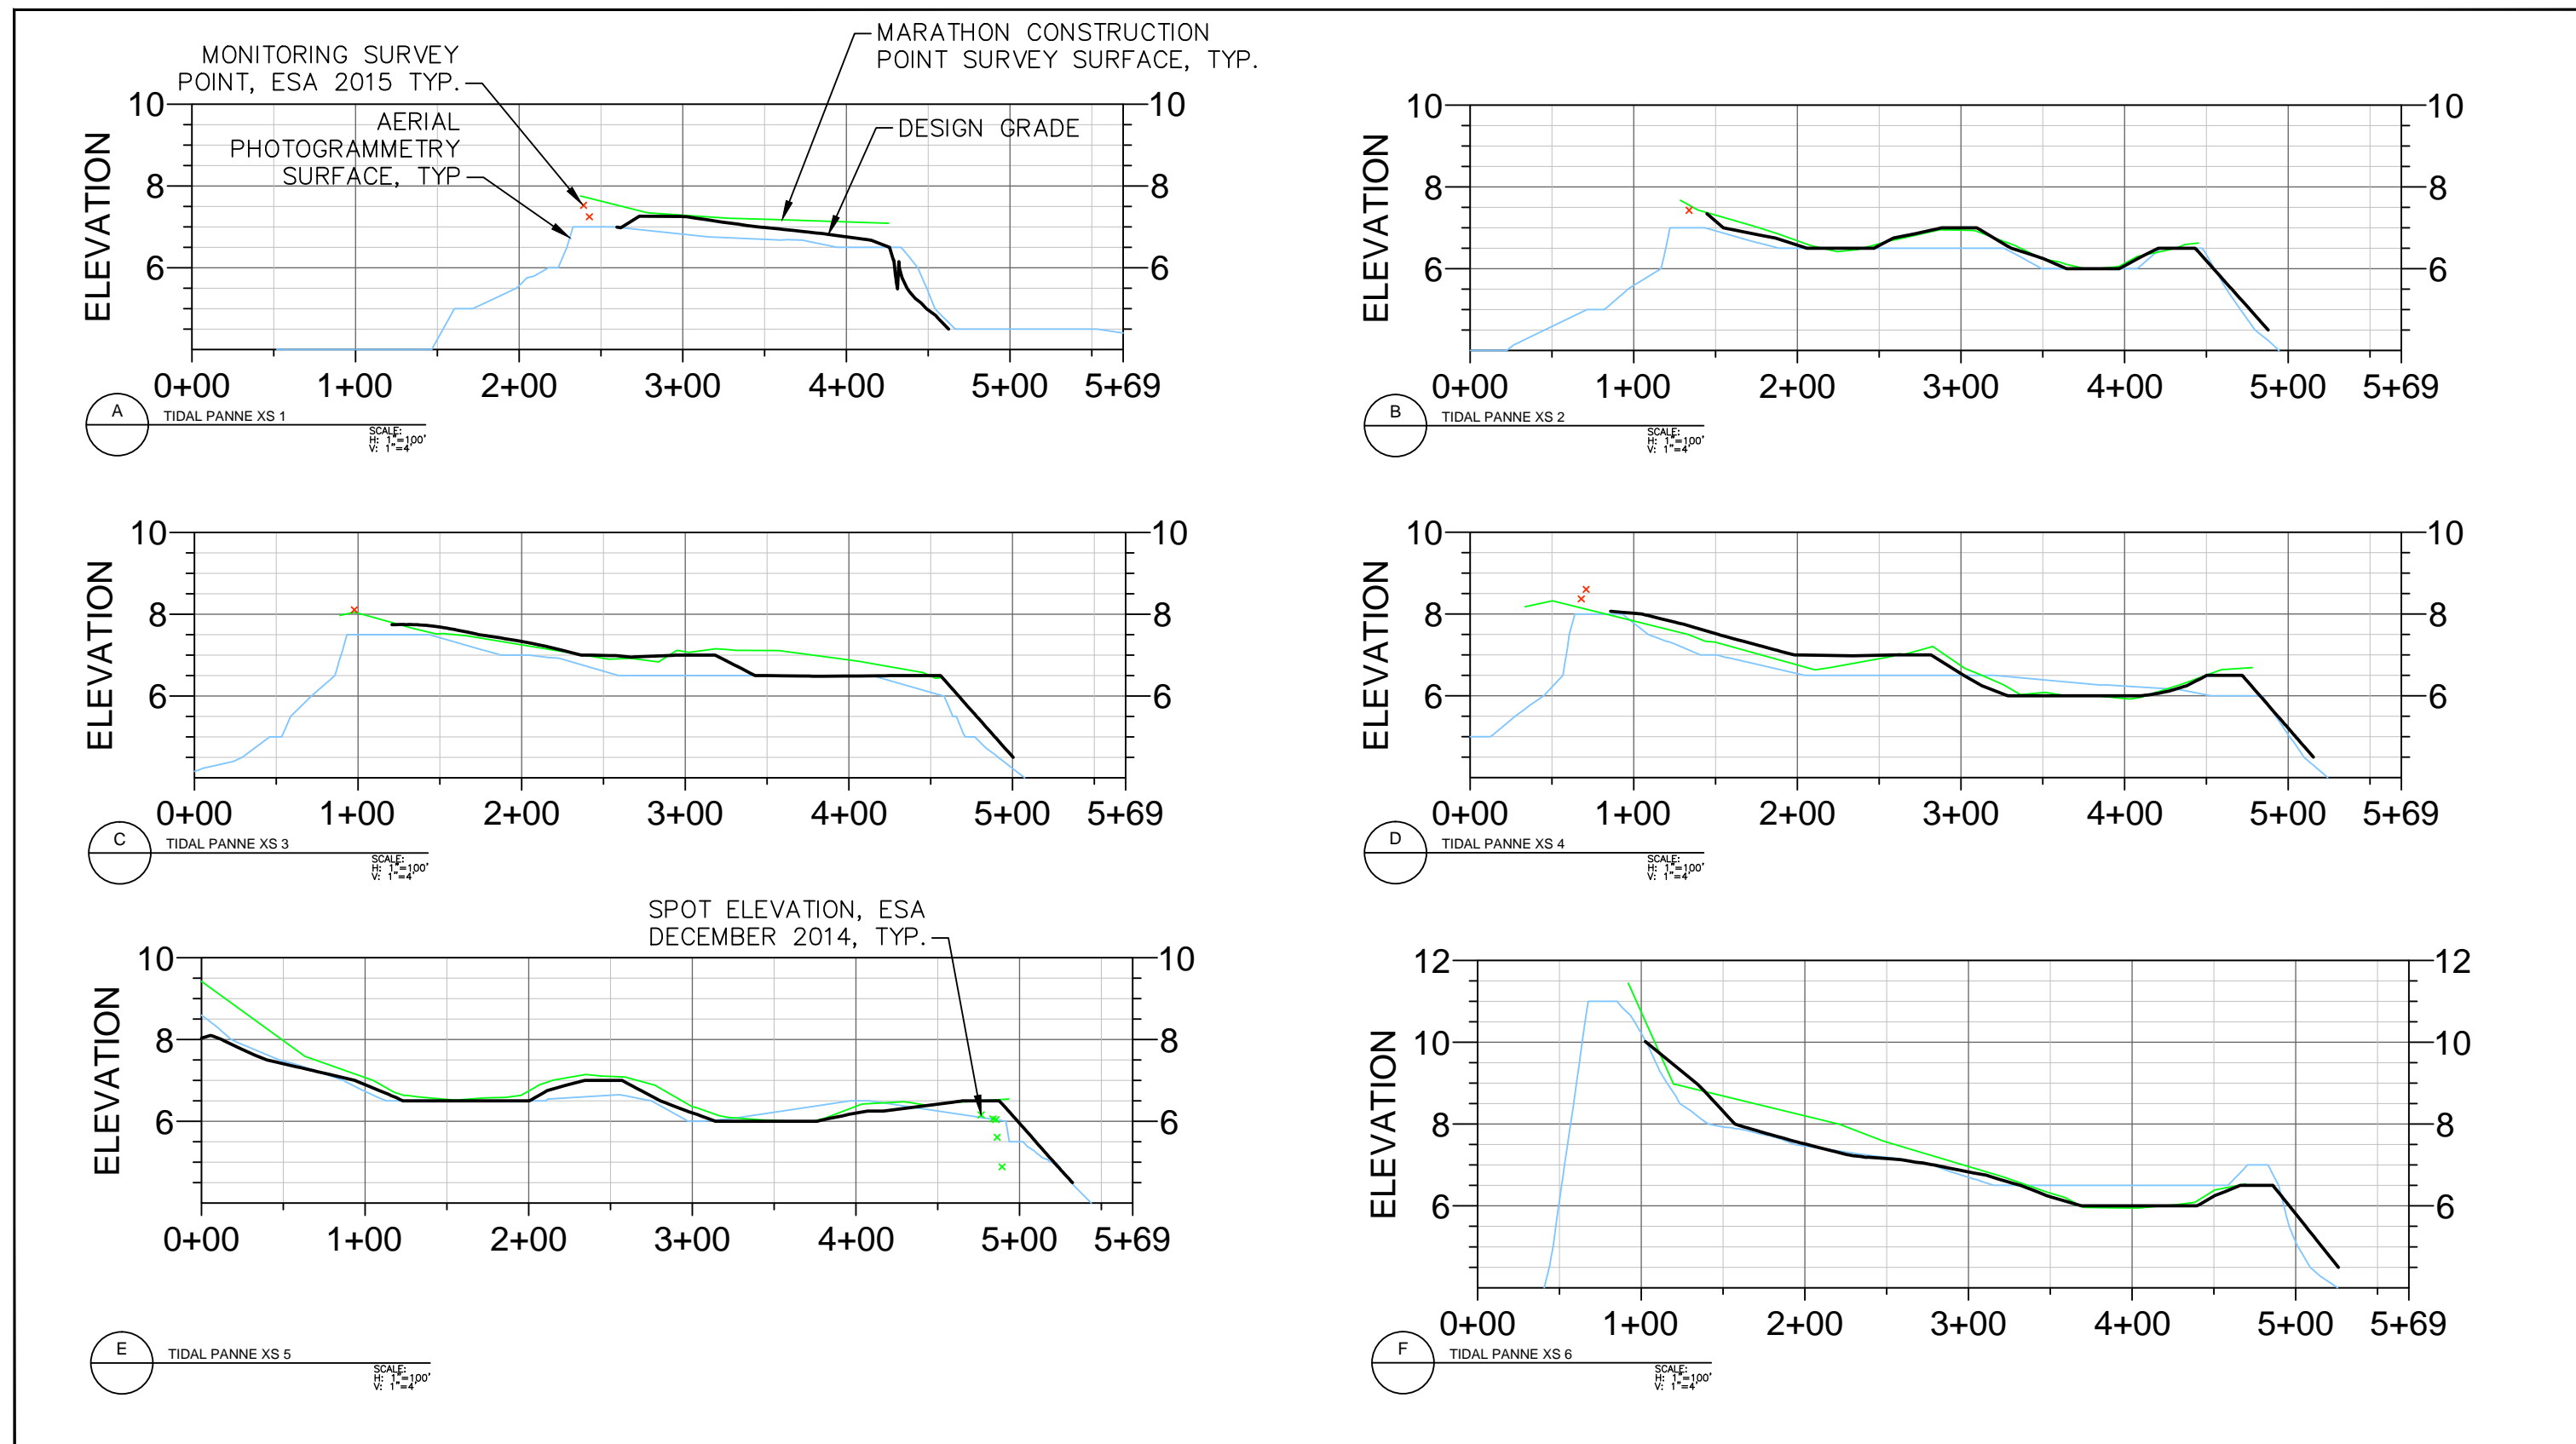
FIGURE 15

- A cross section was surveyed along the lowered NSW/Tidal Pannes levee and along the outboard Tidal Panne sill. As noted in the Tidal Pannes section above, the lowered levee crest is lower than the design elevation at several locations, and has overtopped and exhibited signs of scour during high tide events.

Also the Tidal Pannes Sill also has several areas of erosion that limit ponding within the tidal pannes. Repeated surveys of the berm crest over coming years will provide greater insight as to the rate at which the berm is eroding, and will inform future adaptive management, if needed.
