memorandum

subject Hamilton Wetlands Post-Construction As-Built Survey Review – Breach and Completion Contract.

This memorandum presents the ESA's post-construction assessment of the Hamilton Wetland Restoration Project following the Breach and Completion Contract.

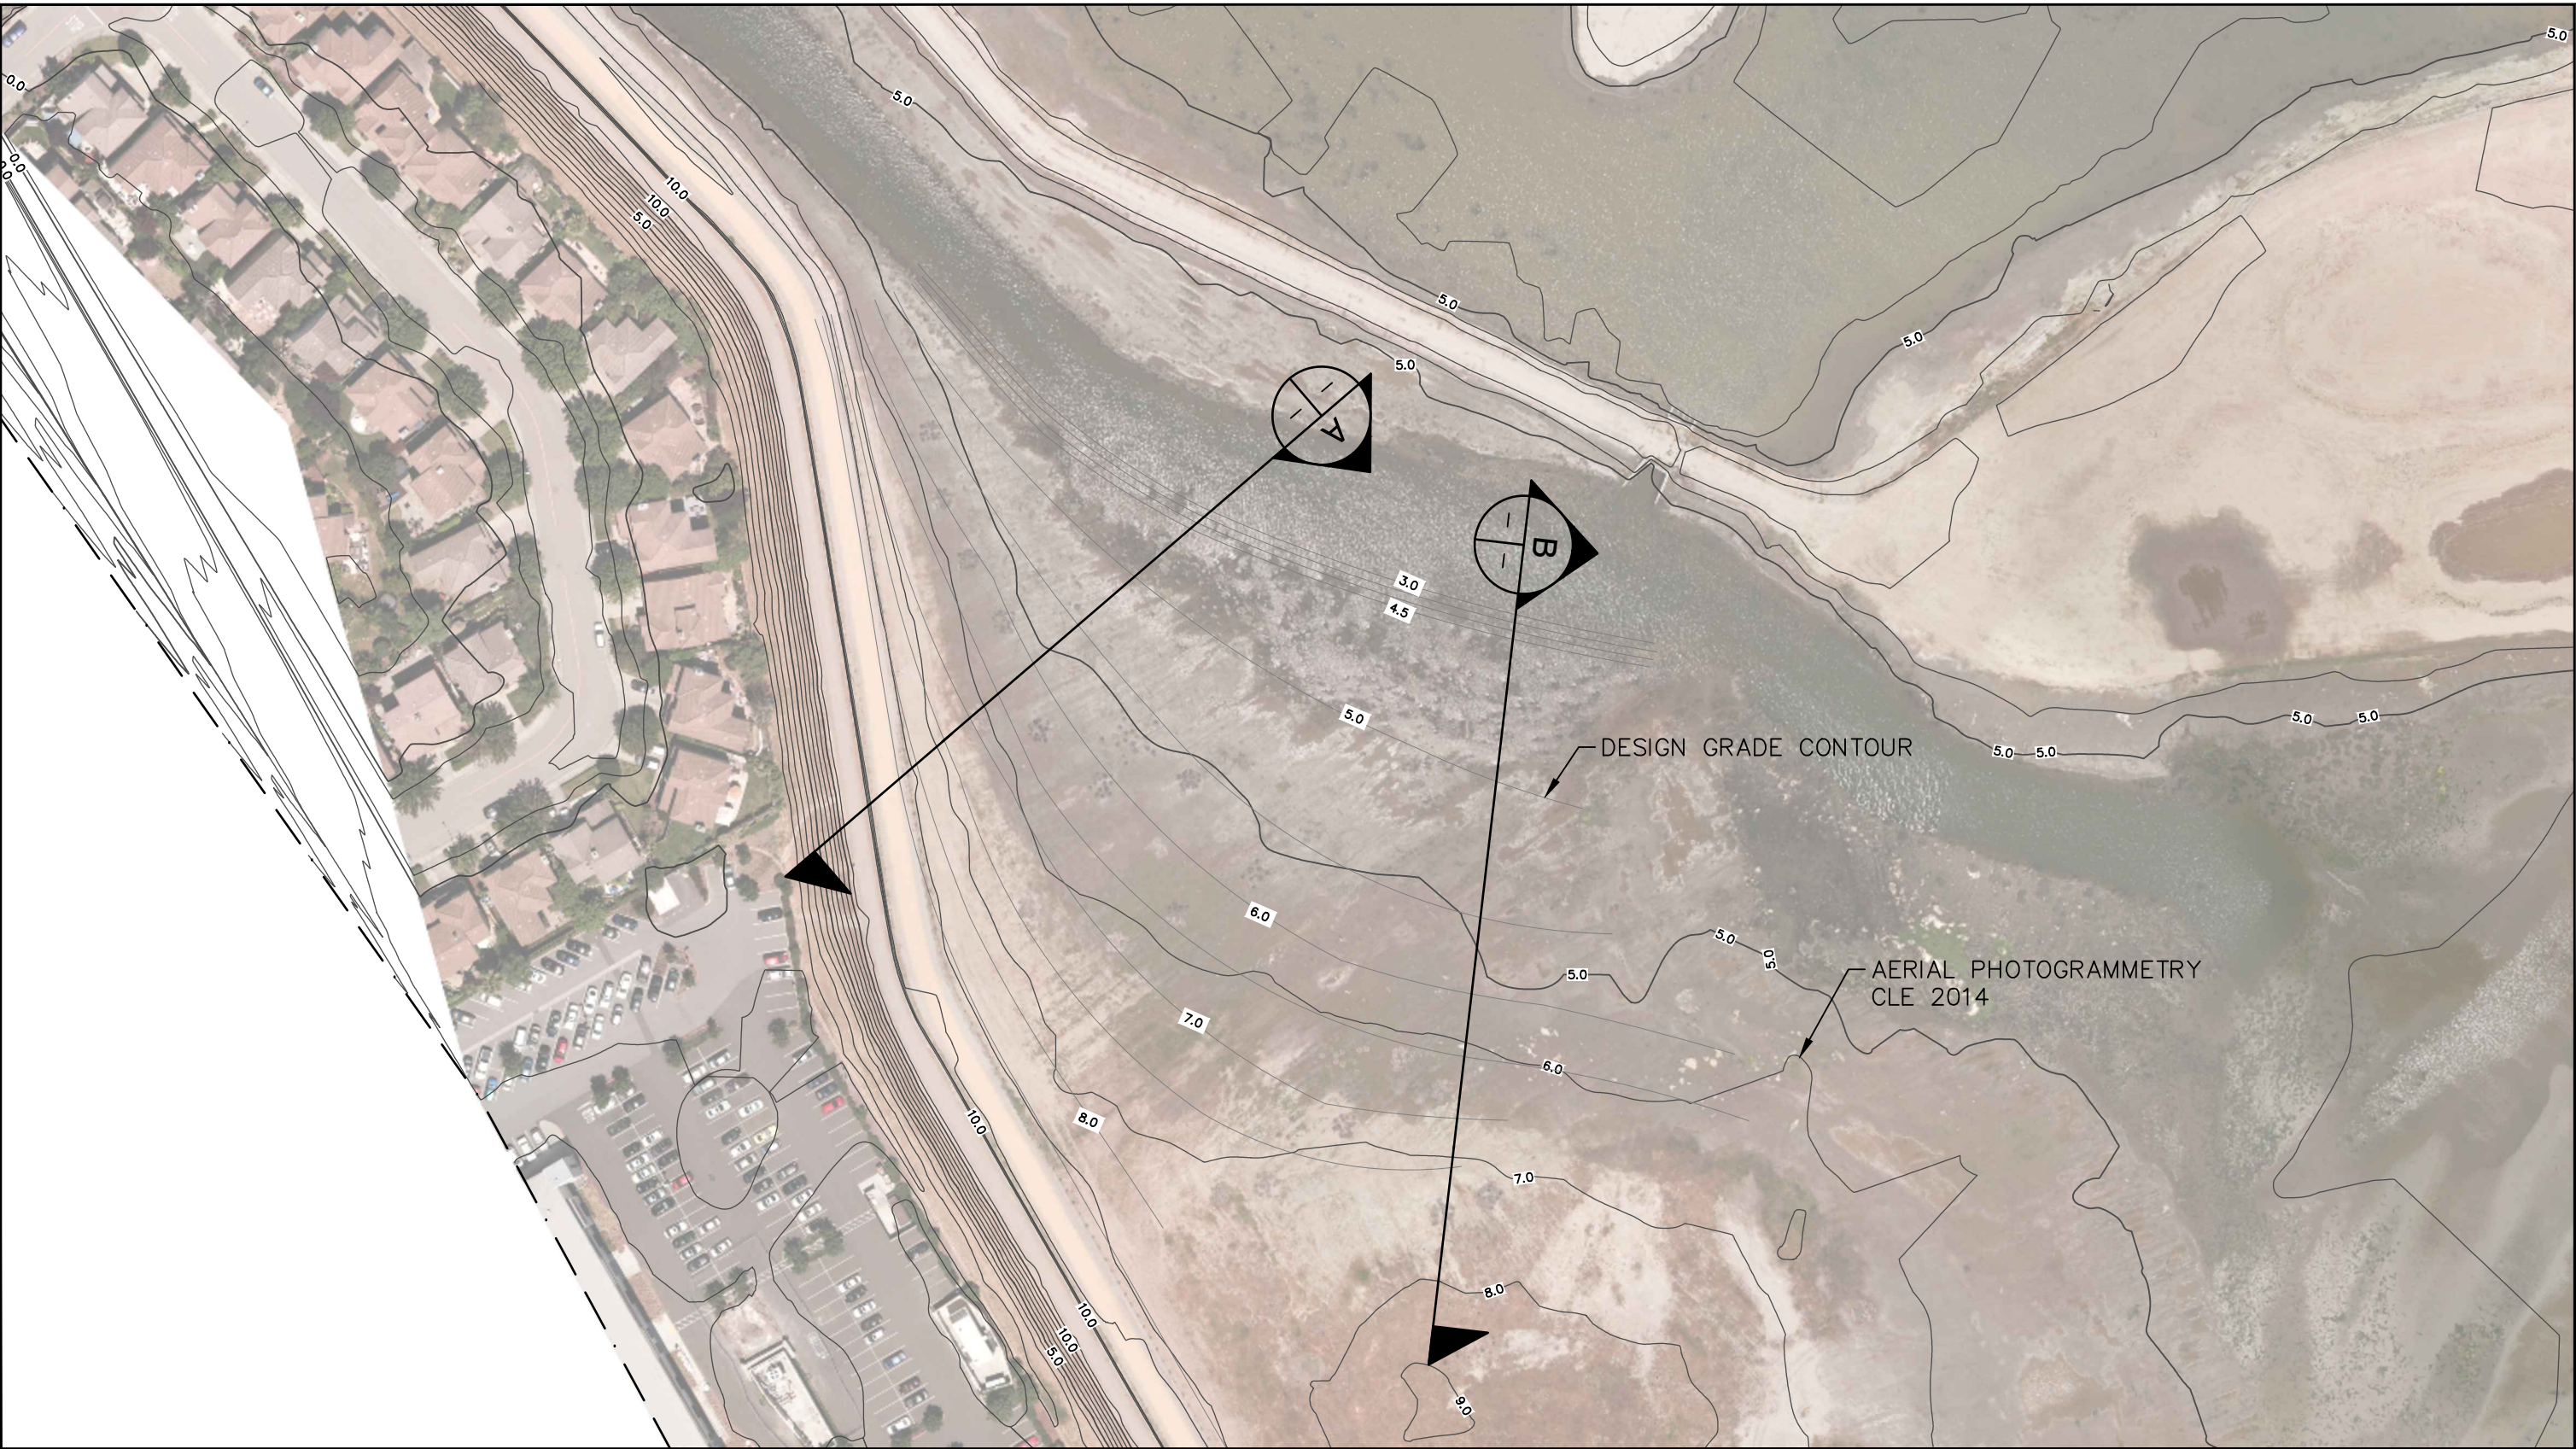
Hamilton Post-Construction Assessment
FIGURE 16
Wildlife Corridor Transition Plan

The Wildlife Corridor Transition, located at the north end of the Wildlife Corridor (WLC), is intended to provide a gradual transition from the broad, flat transitional slope along the WLC to narrower wetland bench along the tidal channel adjacent to the North Seasonal Wetlands. The project design calls for a broad transition area with slopes ranging from about 40 to 80:1. Figure 16 shows a plan view of the design grade and post-construction aerial photogrammetry contours at the WLC Transition. Figure 17 shows two cross sections through the WLC Transition, highlighting the extent to which the as-built grades are lower than the design grades. The majority the WLC Transition area is between 0.5 and 1ft below than the design grade, and does not meet the specified tolerance.

The finished grades ranging from 0.5 to 1 ft below the design grade will result in a narrower transitional slope in this area, significantly reducing vegetated habitat area and reducing high tide refugia adjacent to the NSW tidal channel corridor.

- *The Wildlife Corridor Transition area is too low:* The finish grades at the Wildlife Corridor Transition area are up to 1ft lower than the design grades. This causes more frequent inundation of this tidal marsh area, and reduces the extent of high tide refugia adjacent to the NSW wetland channel corridor. Some parts of the transition area may not fully vegetate, and instead persist as mudflat or subtidal habitat.

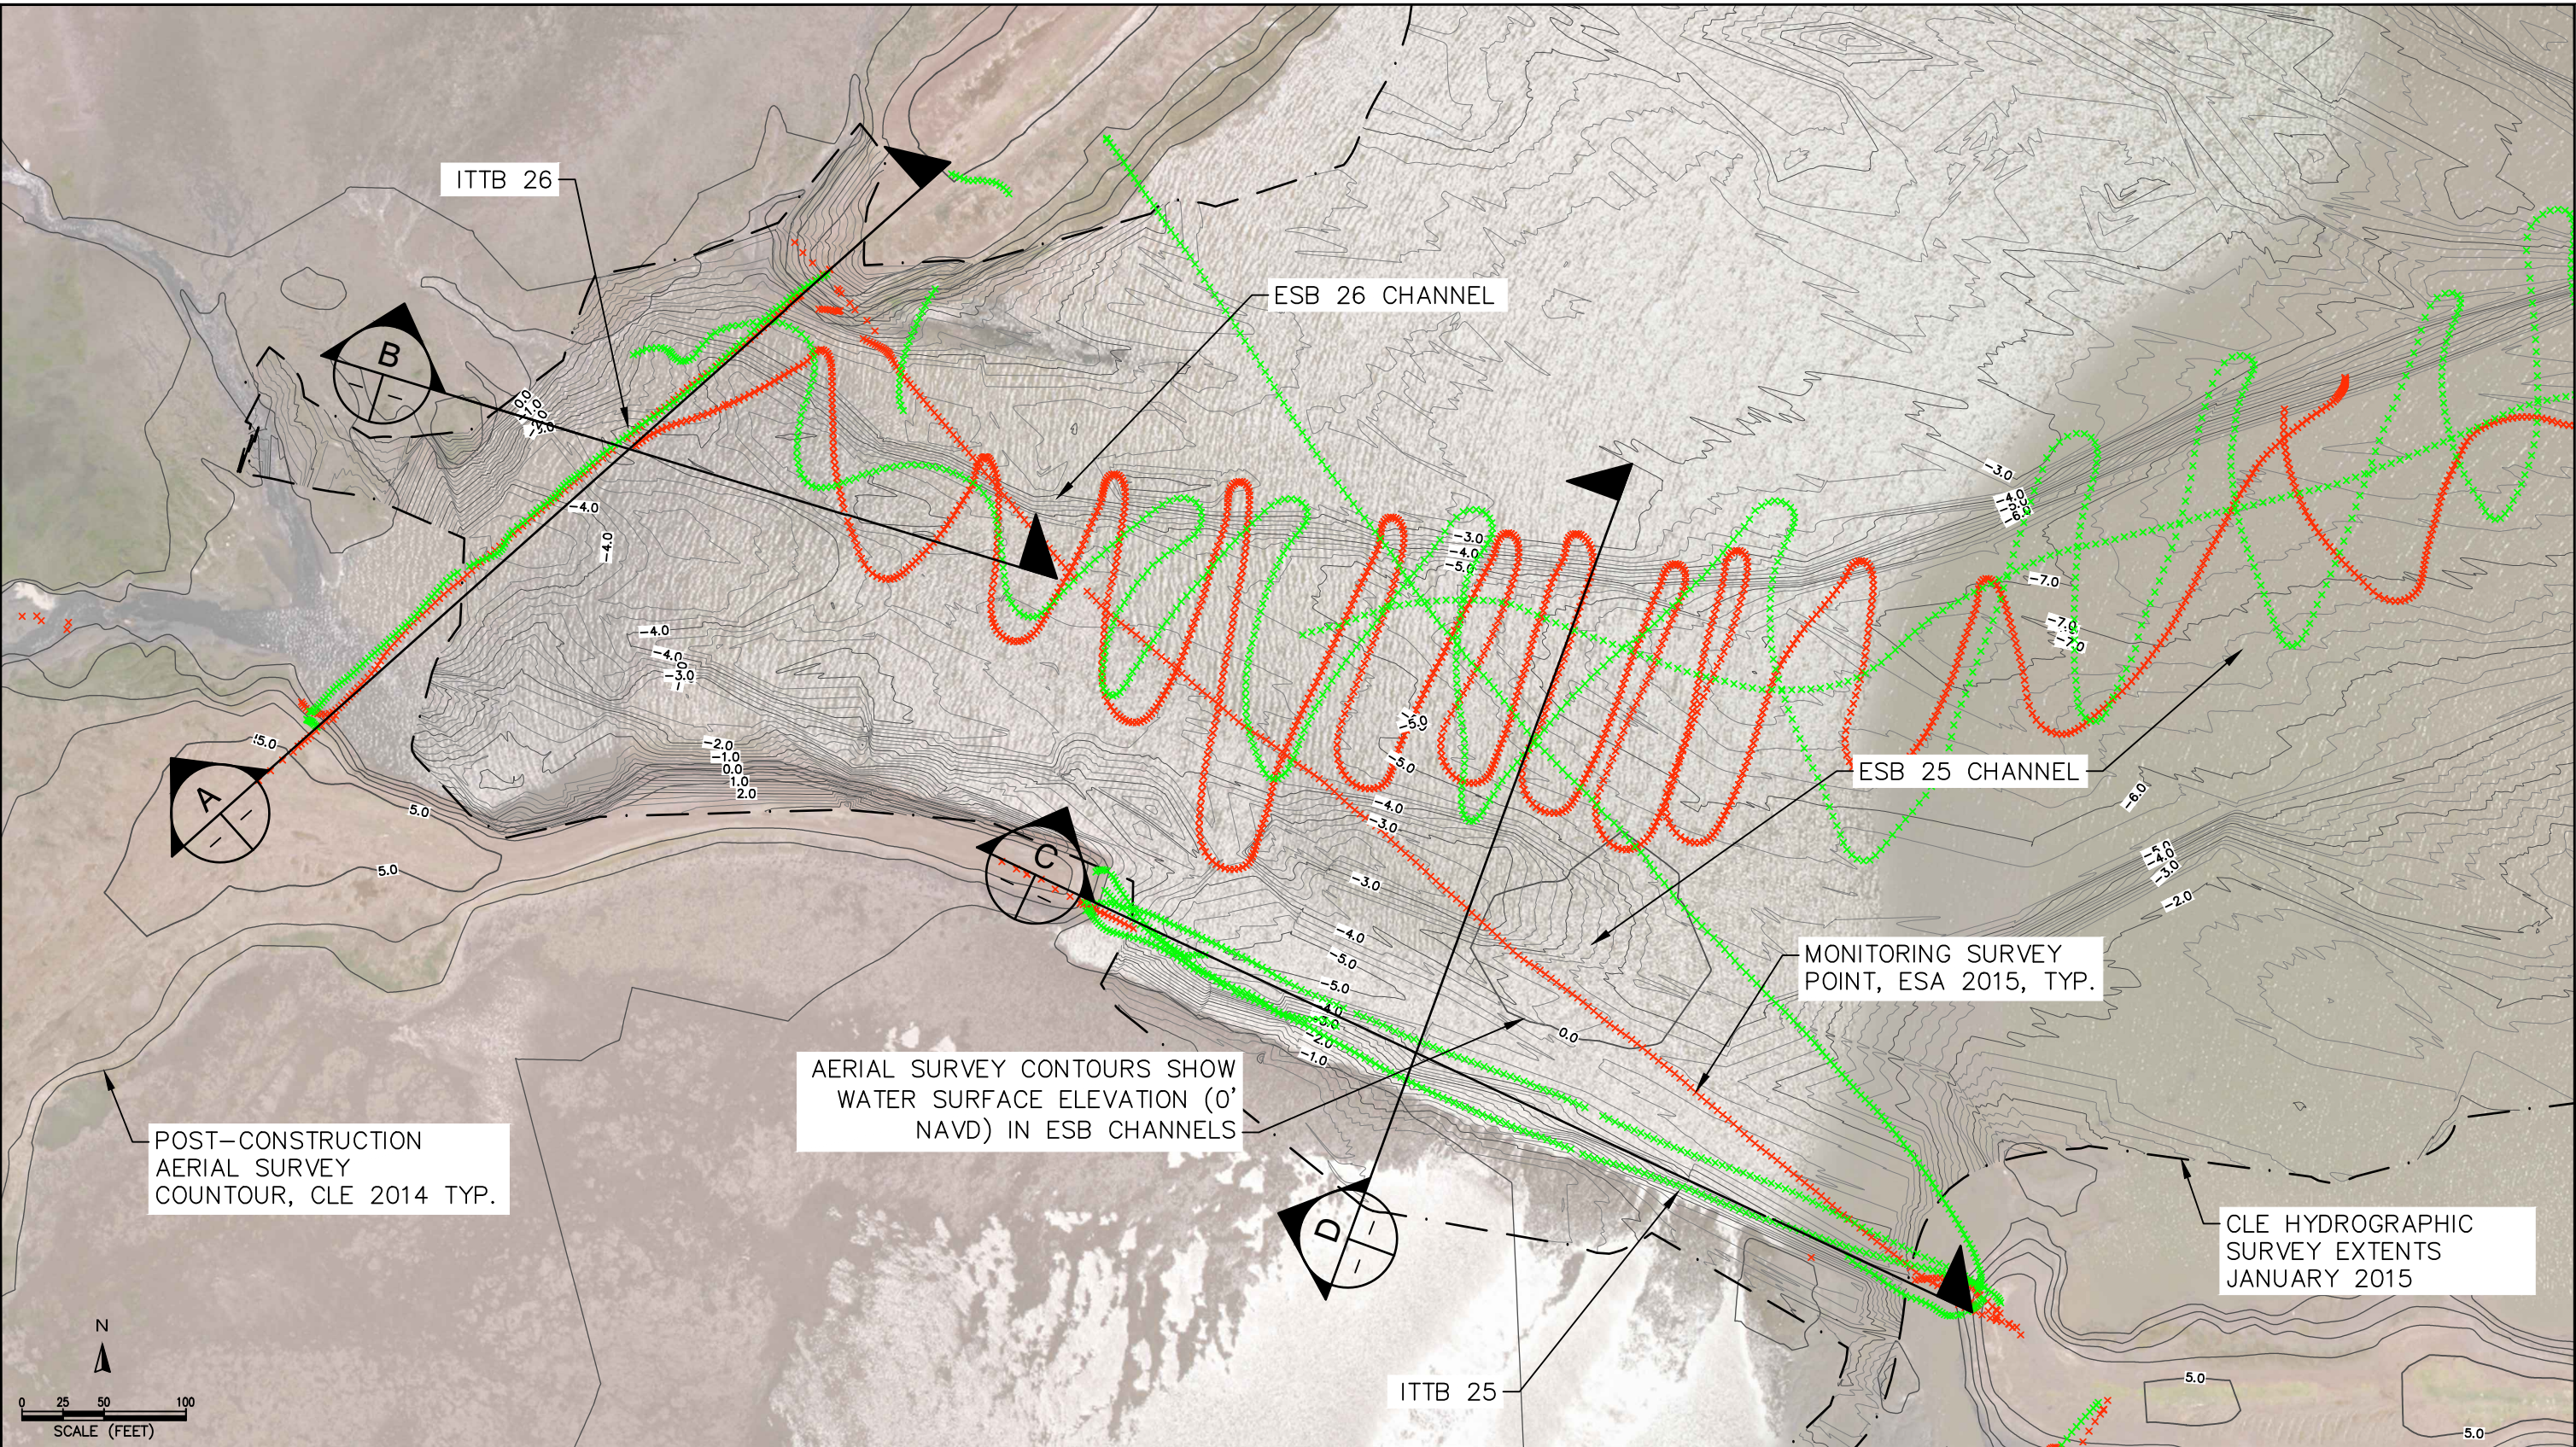
FIGURE 18

Figure 18 shows a plan view of ITBB 25 and 26, showing the location of the available survey datasets at these two breaches, including the CLE Hydrographic Survey from early 2015 (shown as contours) and the ESA Monitoring Surveys, both conducted in Jan/Feb 2015 and Sept 2015. Figure 19 shows cross sections and profiles for these two breaches. Figure 19 also shows channels ESB 25 and 26 excavated within the expanded settling basin. Figures 20 and 21 show the plan view of ITBB 14, and a cross section and profile for this breach.

Table 3 summarizes the findings of the post-construction surveys. Both the CLE and ESA surveys show excavated grades higher than the design grade. The bottom width of all three intertidal berm breaches approximately matches the design width, however the excavated depths were all above tolerance at the time of surveys. The excavated depths ranged from 1.5 to 3 feet above design grades at ITTB 25, 1.5 to 2 feet above design grade at ITTB 26, and 1 to 2.5 feet above design at ITTB 14. Since the surveys were performed several months following construction, it is not clear if these intertidal berm breaches were under-excavated at the time of construction or if the soft dredge material migrated into the excavated breach. The more recent monitoring surveys conducted in the fall of 2015 suggest that these intertidal berm breaches may be filling with poorly consolidated sediment from the adjacent mudflats, these findings will be discussed further in the Year-1 monitoring report. The evolution of these breaches will continue to be monitored.

Also in the vicinity of ITTB 25 and 26 are excavated channels ESB 25 and 26 within the expanded settling basin. Based on the CLE hydrographic survey (Feb 2015), Channel ESB 25 appears to be excavated to design width and depth in the reach to the east of the bifurcation with ESB 26. However, west of the bifurcation, ESB 25 appears to have been under excavated in both width (80' constructed vs. 210' design width) and depth (EL -5.5' constructed vs. EL -6.5' design). Channel ESB 26 appears to approximately match the design width, while being under excavated in depth (EL 4.5' constructed vs. EL 6.0' design). Similar to the intertidal berm breaches, it's not clear if the ESB channels were excavated to depth during construction, and the surveyed depths reflect sediment and dredge materials settling within the low channel bottom.

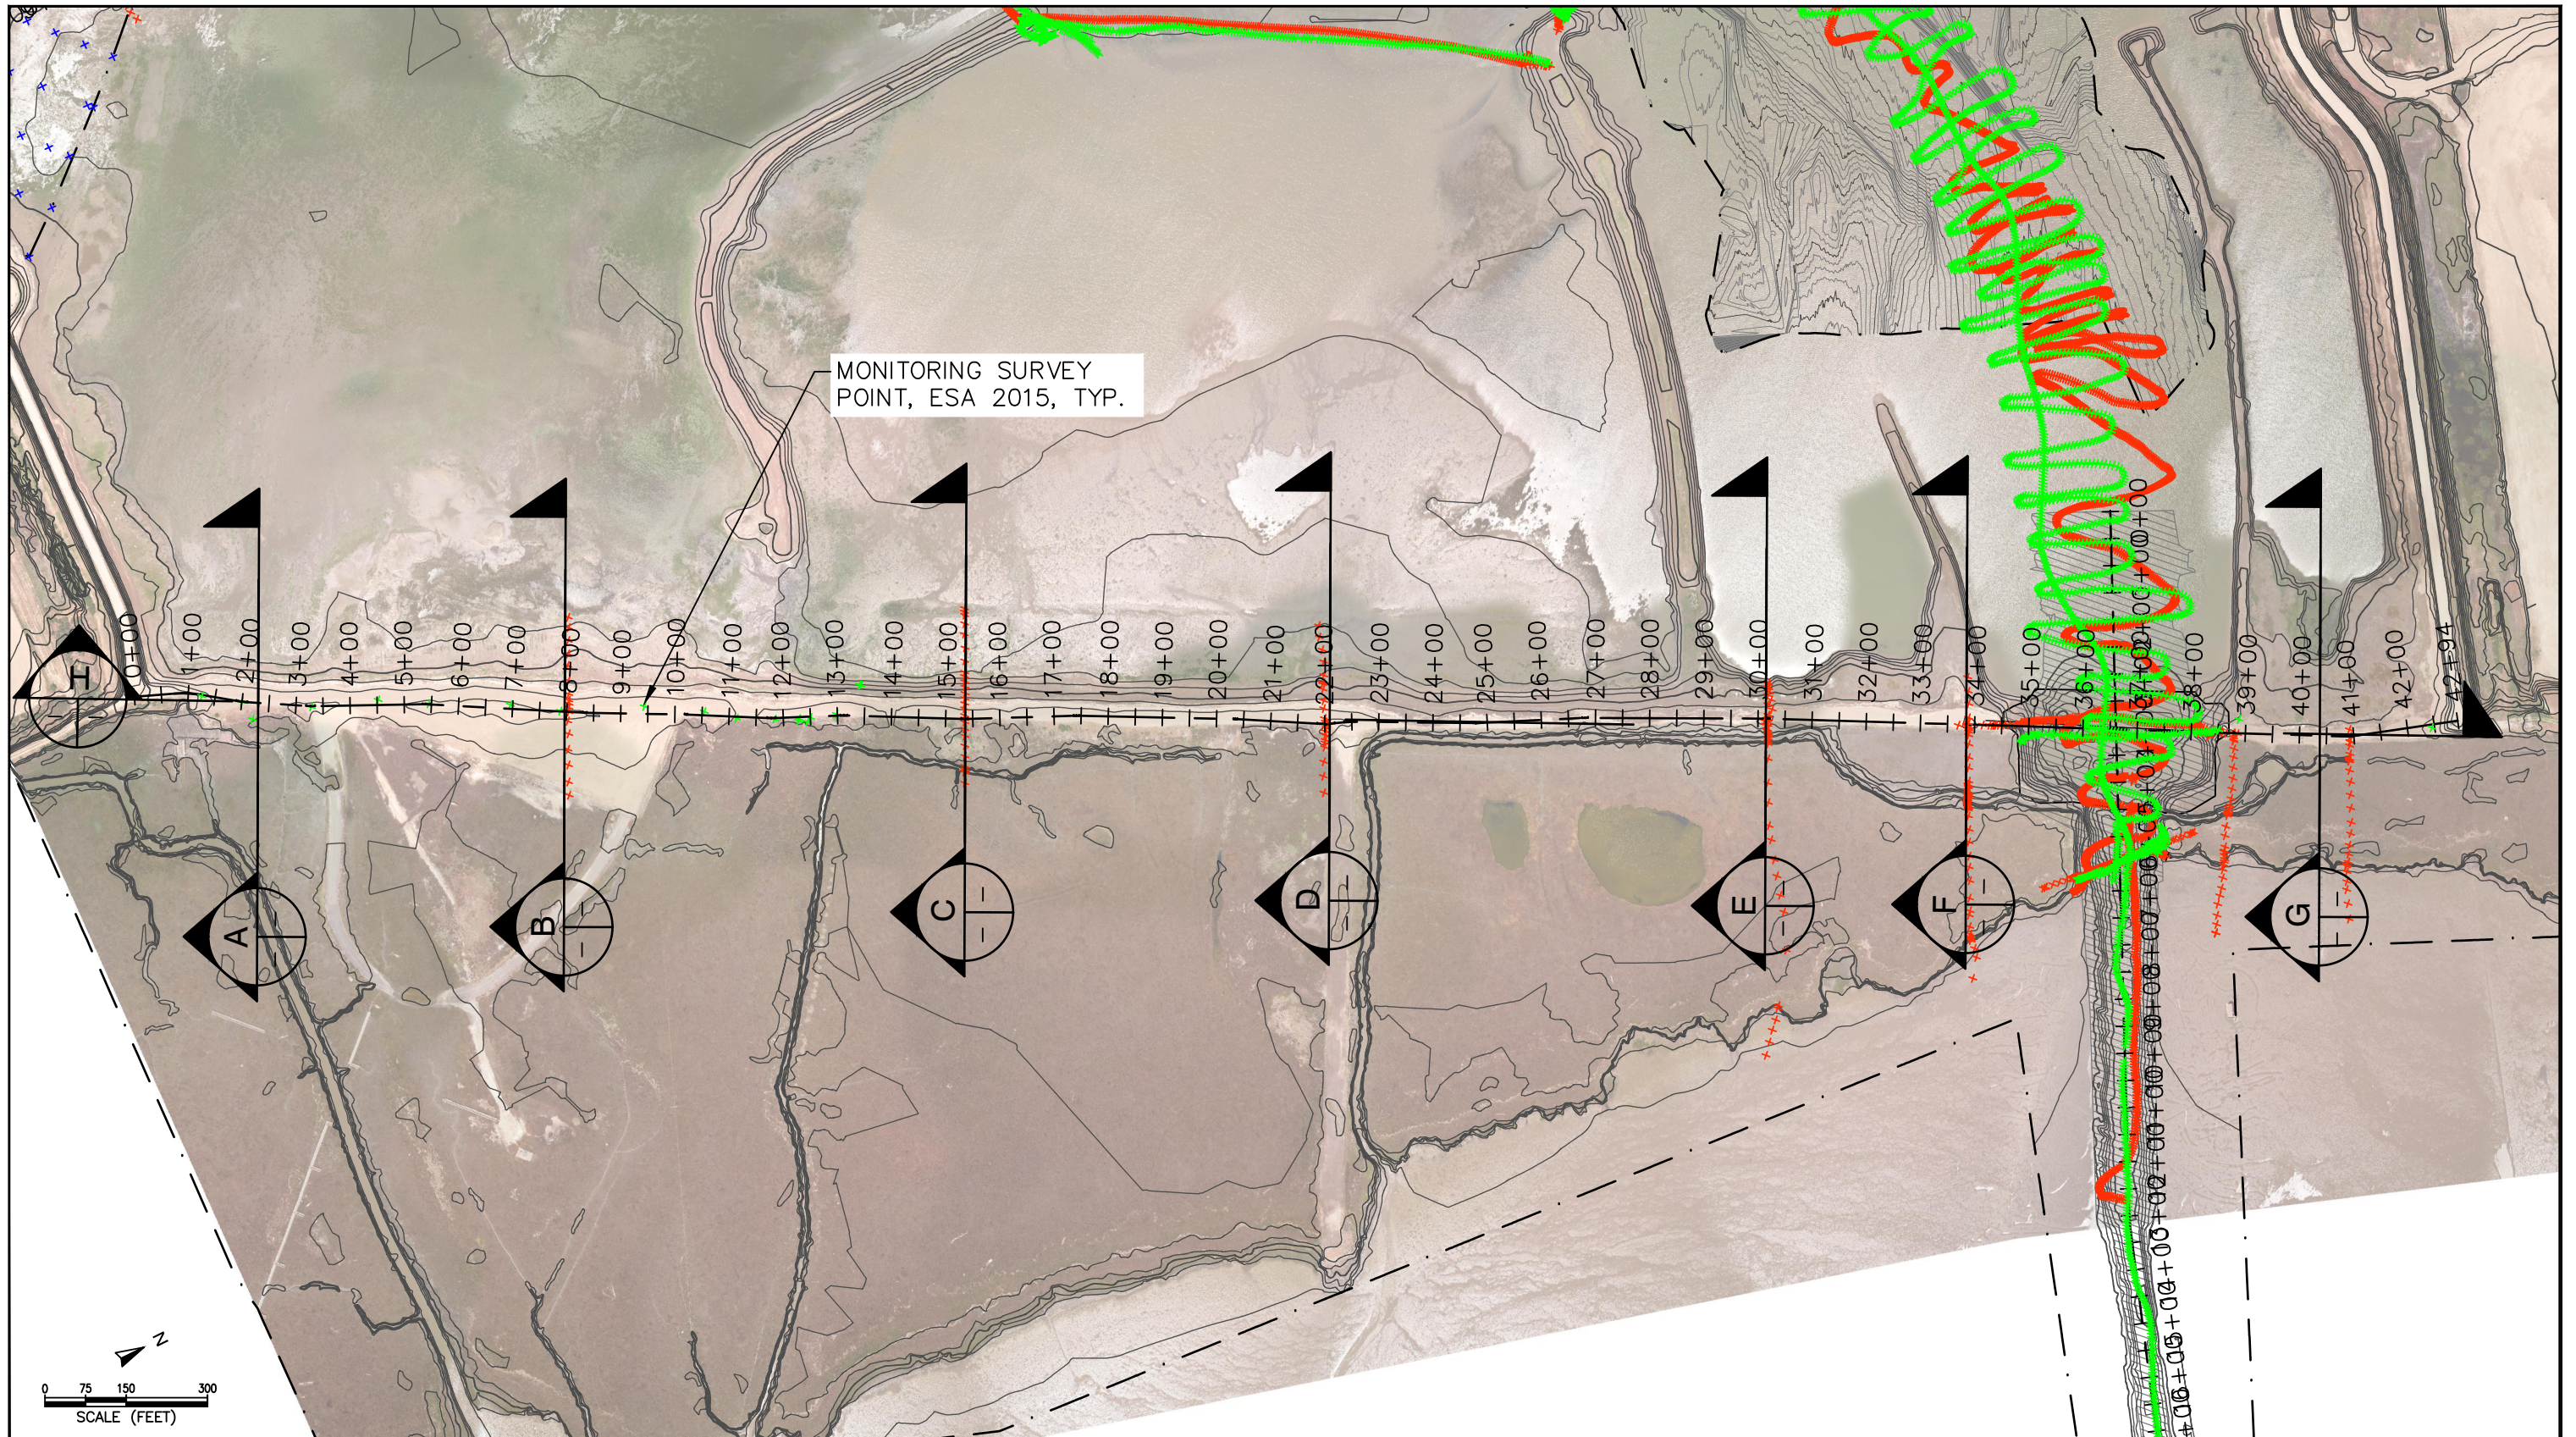
Hamilton Post-Construction Assessment
FIGURE 29
 Outboard Levee Plan View

The outboard levee separates the restored project area from the existing bayfront marsh. This levee was to be lowered to provide a smooth transition between the inboard and outboard marshes. The design grade of this feature sloped from ~EL 7.0 ft (@ limit of native marsh vegetation) along the outboard marsh to EL 5.1 ft at the inboard side of the levee. The as-built crest elevation was found to be considerably higher than the design grade, reaching elevations up to 8.72 ft, and consistently exceeding EL 8.0 ft for long stretches. Figure 29 shows a plan

view of the outboard levee, including the location of spot elevations collected by ESA. Figure 30 shows several cross sections cut along the length of the outboard levee, showing as-built grades captured by the aerial photogrammetry as well as the design grade. Figure 31 shows a profile along the centerline of the outboard levee, showing as-built grades captured by the aerial photogrammetry, as well as high points captured in the ESA monitoring survey. This figure also highlights the EL 7.0 ft, the maximum allowed elevation of the lowered levee.

The design indicates that the levee lowering should create a slope from the existing elevation 7.0' contour on the outboard side of the levee to the inboard EL 5.1 ft contour. Therefore we would expect the post-construction grades along the levee centerline to be between EL 5.1 and 7.0 ft, however the post-construction survey shows elevations above EL 7.0 ft almost contiguously between stations 0+00 and 23+00, and at several other locations along the length of the levee. This suggests that nearly half of the outboard levee was not lowered to the correct elevation.

- *The Outboard Levee is too high:* The higher crest of the outboard levee is preventing occasional overtopping and inundation along the levee crest which will limit sediment delivery to the site during storm surges. In addition the higher elevation will limit natural colonization of native vegetation along the lowered levee because considerable stretches of the outboard levee crest are well above the tide range. Up to 4 to 5 acres of the outboard levee may be too high for native vegetation to establish.

- Lower the outboard levee to design grades including the clean clay soil cap as required by the contract.
 - If lowering the outboard levee is not practicable, native plantings appropriate for high marsh and transitional zones (similar to those for the Wildlife Corridor) should be planted along the higher reaches of the outboard levee limit establishment of non-native vegetation including perennial pepperweed.

- Vegetation establishment should be closely monitored and non-native control efforts should be undertaken to limit the establishment of non-native plant communities on the higher areas of the outboard levee.
