Year 2 – 2017 Monitoring Report

Hamilton Wetland Restoration Project

U.S. Army Corps of Engineers – San Francisco
District

HDR Inc. in association with:
Environmental Sciences Associates
Avocet Research Associates, LLC
Towill Inc.
BMP Ecosciences

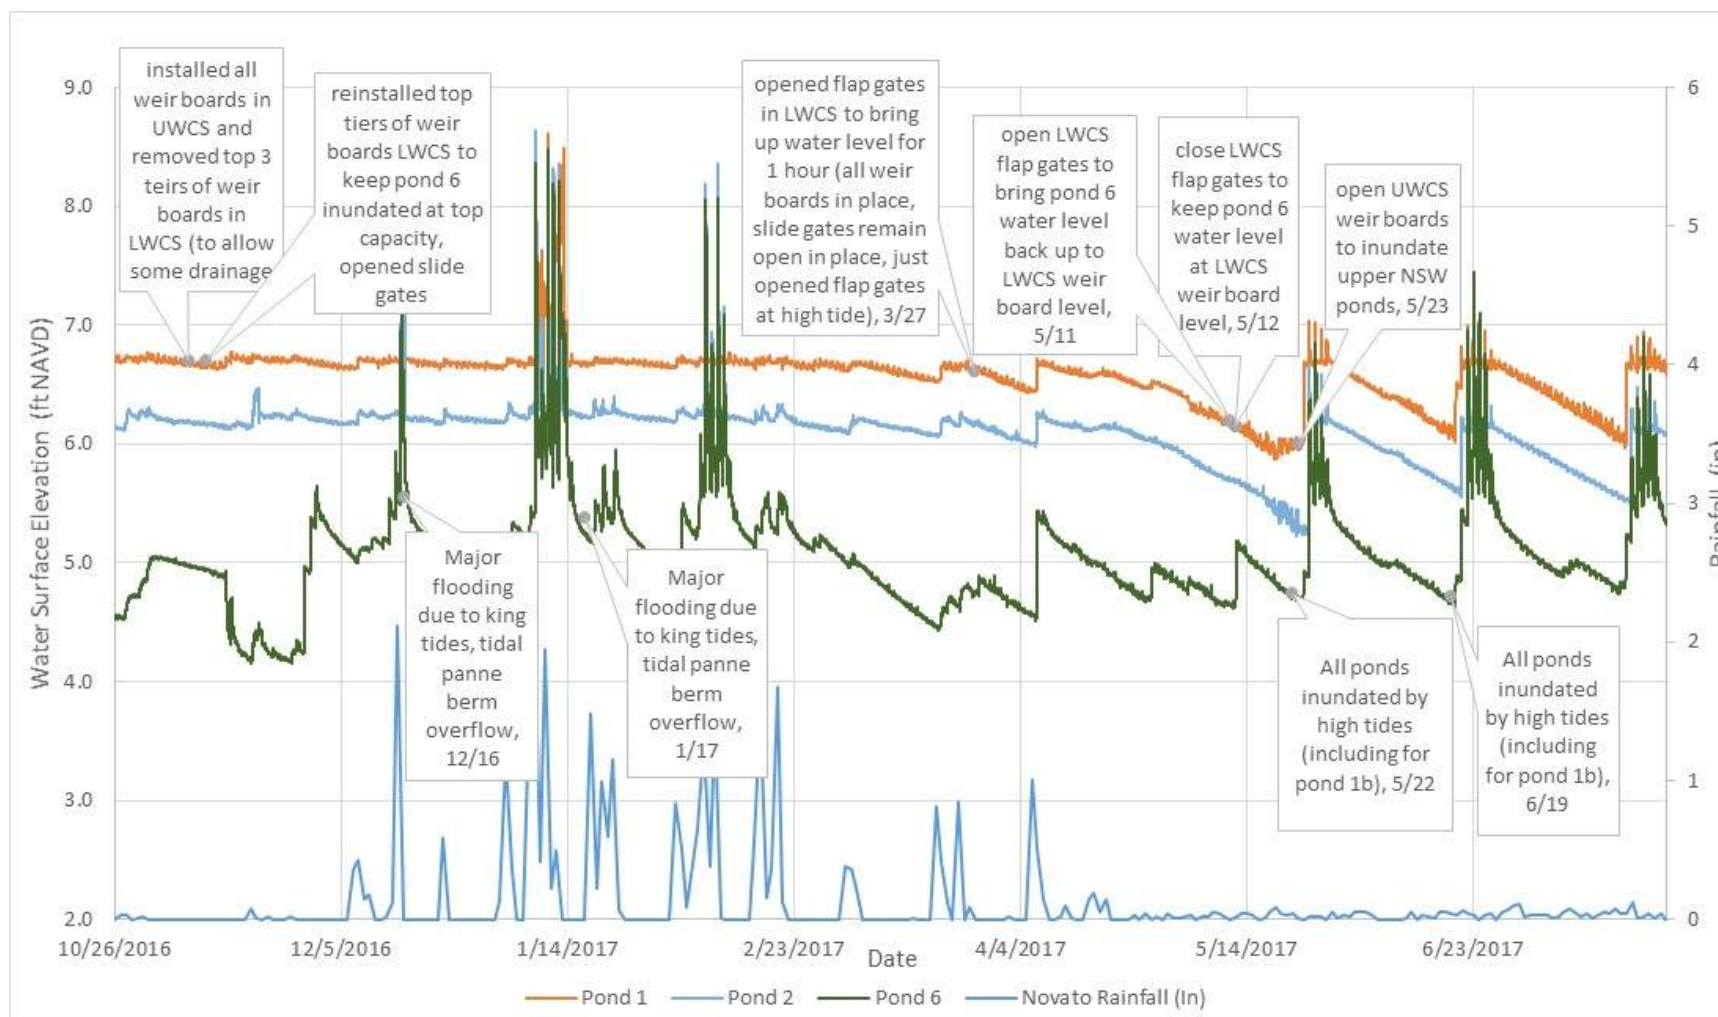
Figure 2-7. North Seasonal Wetland Pond Water Levels

three different high tide cycles. Water surface elevation increases influenced exclusively by rainfall events were observed numerous times through this same period, as well as in March and April, 2017. Ponds 1 and 2 are at different elevations, but both are relatively shallow (1 and 1.5 ft deep, respectively) and overtop with significant rainfall. Pond 6 is the deepest and lowest pond in the North Seasonal Wetland and receives excess rainfall-runoff from the five upgradient ponds. Pond 6 water levels are much more sensitive to rain events than Ponds 1 and 2 and display similar timing but variable magnitude of elevation change during rainfall events.

The rate of infiltration and evaporation for Ponds 1 and 2 remained nearly identical over the course of Year 2 monitoring, although Pond 2 sits almost exactly 1-ft lower than Pond 1. The upper weir boards, located at the far west end of the site, divide the North Seasonal Wetlands from the tidal channel on the southern side of the panhandle. On November 8, 2016, all weir boards at the UWCS were installed and remained in place until May 23, 2017.
