memorandum

subject Hamilton Wetlands Post-Construction As-Built Survey Review – Breach and Completion Contract.

This memorandum presents the ESA's post-construction assessment of the Hamilton Wetland Restoration Project following the Breach and Completion Contract.

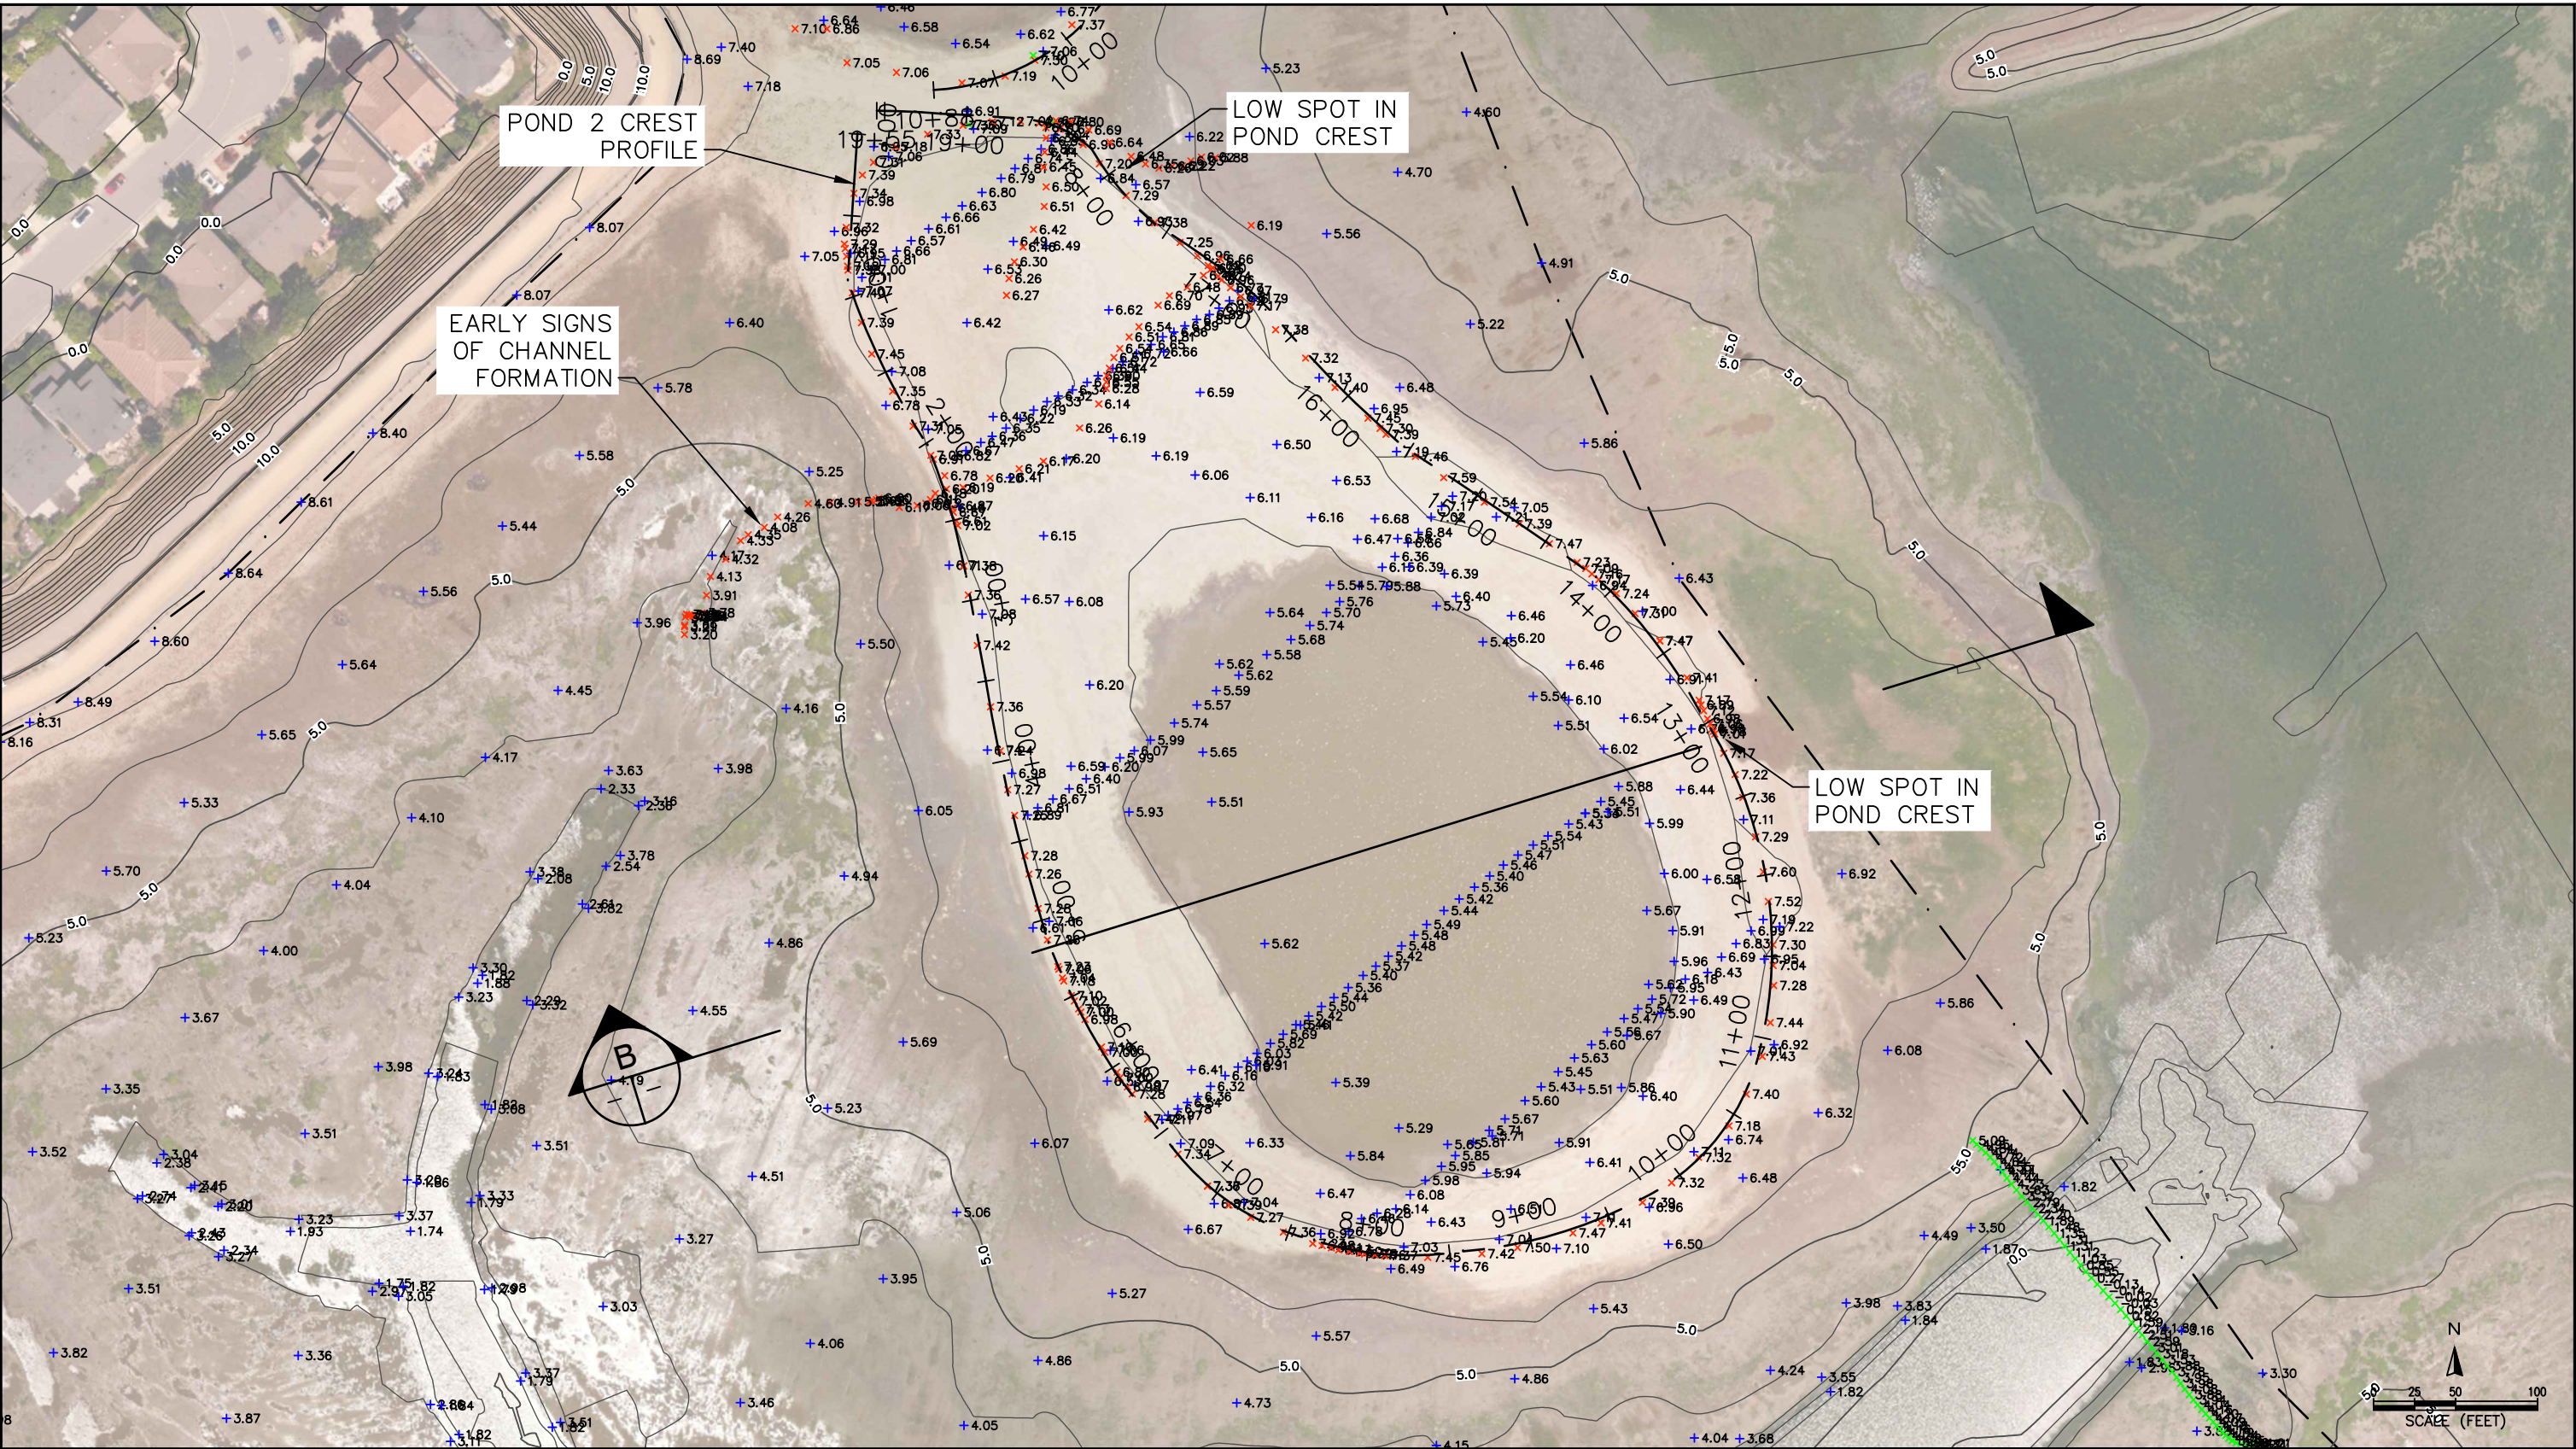
Hamilton Post-Construction Assessment
FIGURE 2
As-Built Surveys - SSW Pond 1

Figures 2 through 5 show the as-built survey data for the various SSW ponds including points collected by Marathon post construction, Aerial photogrammetry, and points surveyed by ESA around the pond crest. Figure 6 shows the difference between the design grade and the post-construction aerial photogrammetry, and Figure 7 shows the difference between the design grade and the post-construction ground survey. Figure 6 highlights significant areas of the SSW marshplain and ponds generally below design grades beyond the design tolerance. Figure 7 shows a smaller extent of out-of-tolerance elevations, but still shows many areas significantly outside of the ± 0.5 ft design tolerance.

- The South Seasonal Wetland pond crests were surveyed and found to contain segments that are below the design elevations. Pond 1 in particular has exhibited significant erosion and channel formation, resulting in nearly complete drainage of the pond area during low tides. Under current conditions the hydrology of Pond 1 is more comparable to a mudflat or tidal marsh area rather than a seasonal wetland pond. The other pond crests appear to be sufficiently intact to provide ponded habitat, however they too may transition to mudflat or tidal marsh should their crests continue to erode.

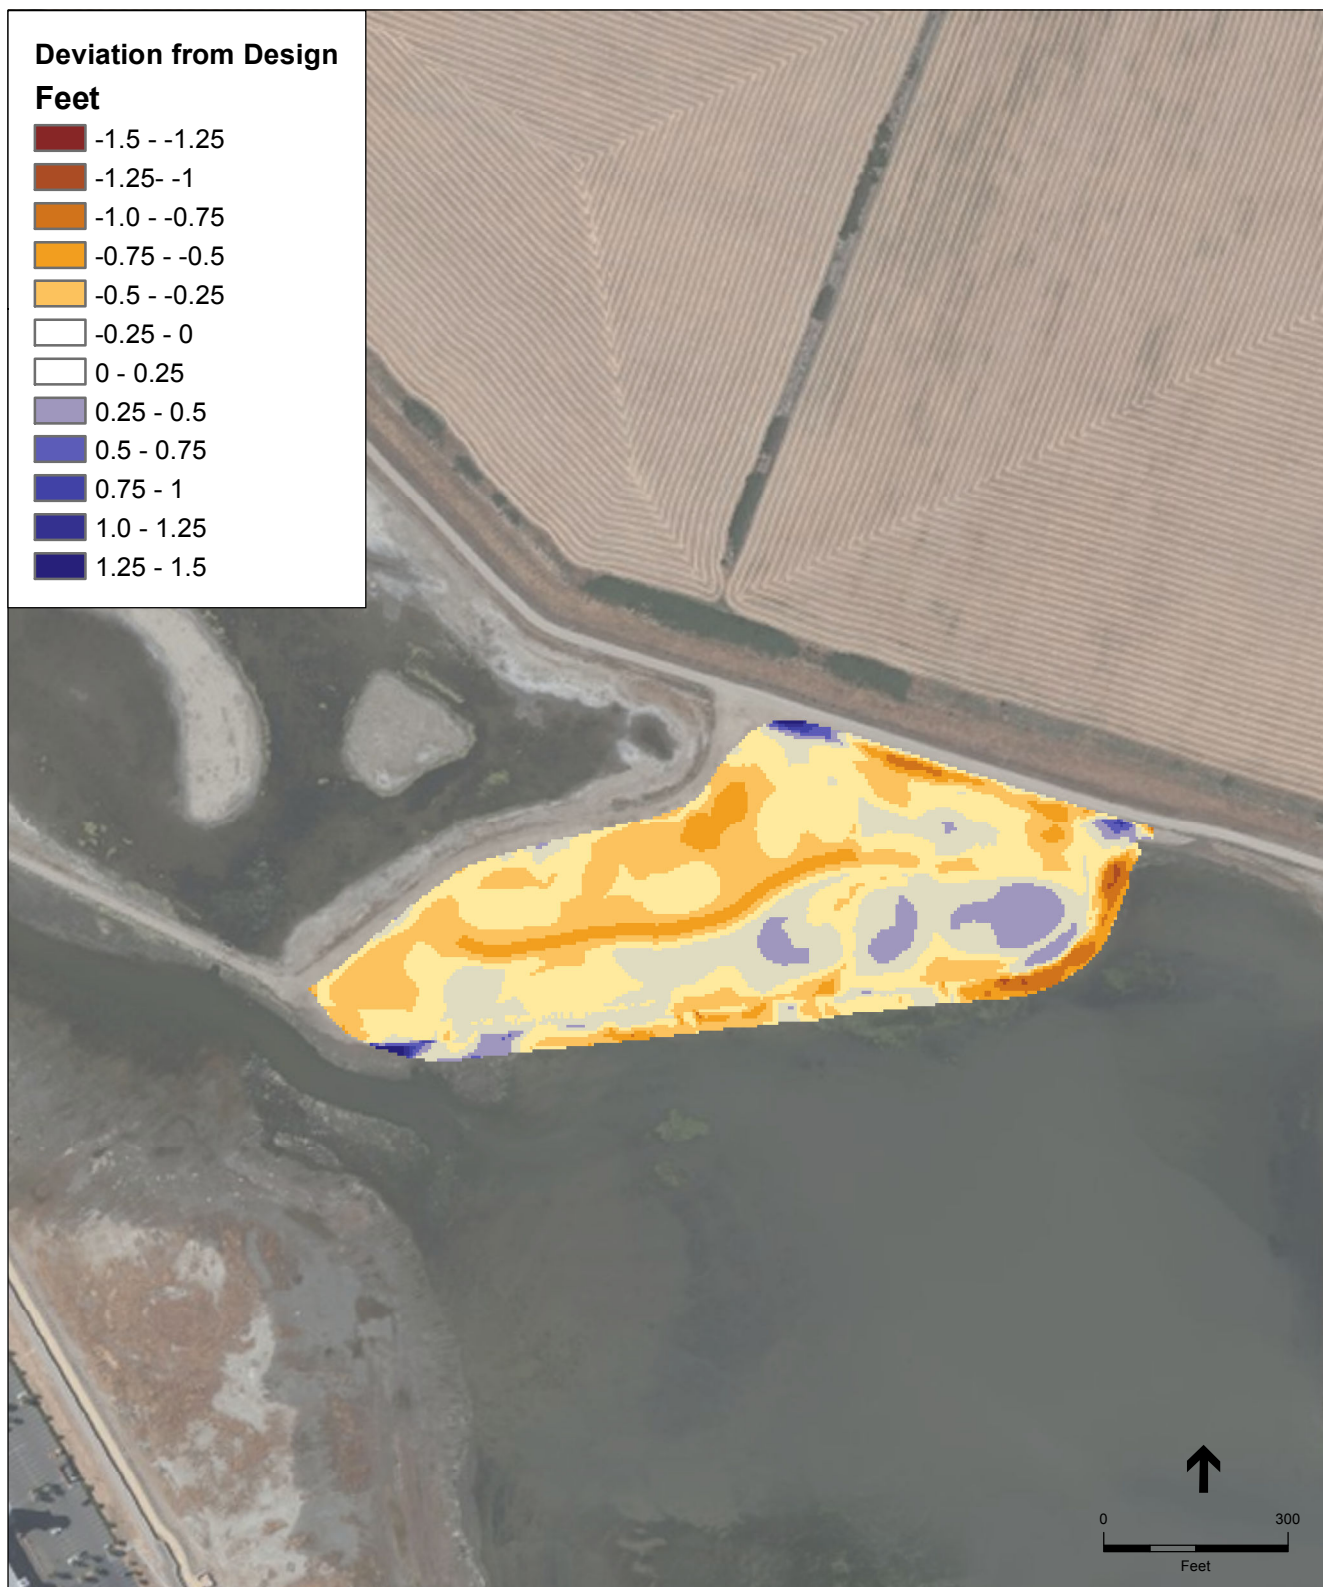
FIGURE 12

Figure 12 shows the as-built surveys for the Tidal Pannes including contours from the aerial photogrammetry, spot elevations collected post construction, and spot elevations along the NSW berm collected by ESA. Figure 13 shows the difference between the design grade and the post-construction ground survey. Figure 14 shows the difference between the design grade and the post-construction aerial photogrammetry. Figure 15 shows typical cross sections of the Tidal Pannes. Note that the point survey data show close agreement to the design grades, while the aerial photogrammetry survey shows larger deviations from the design grade.

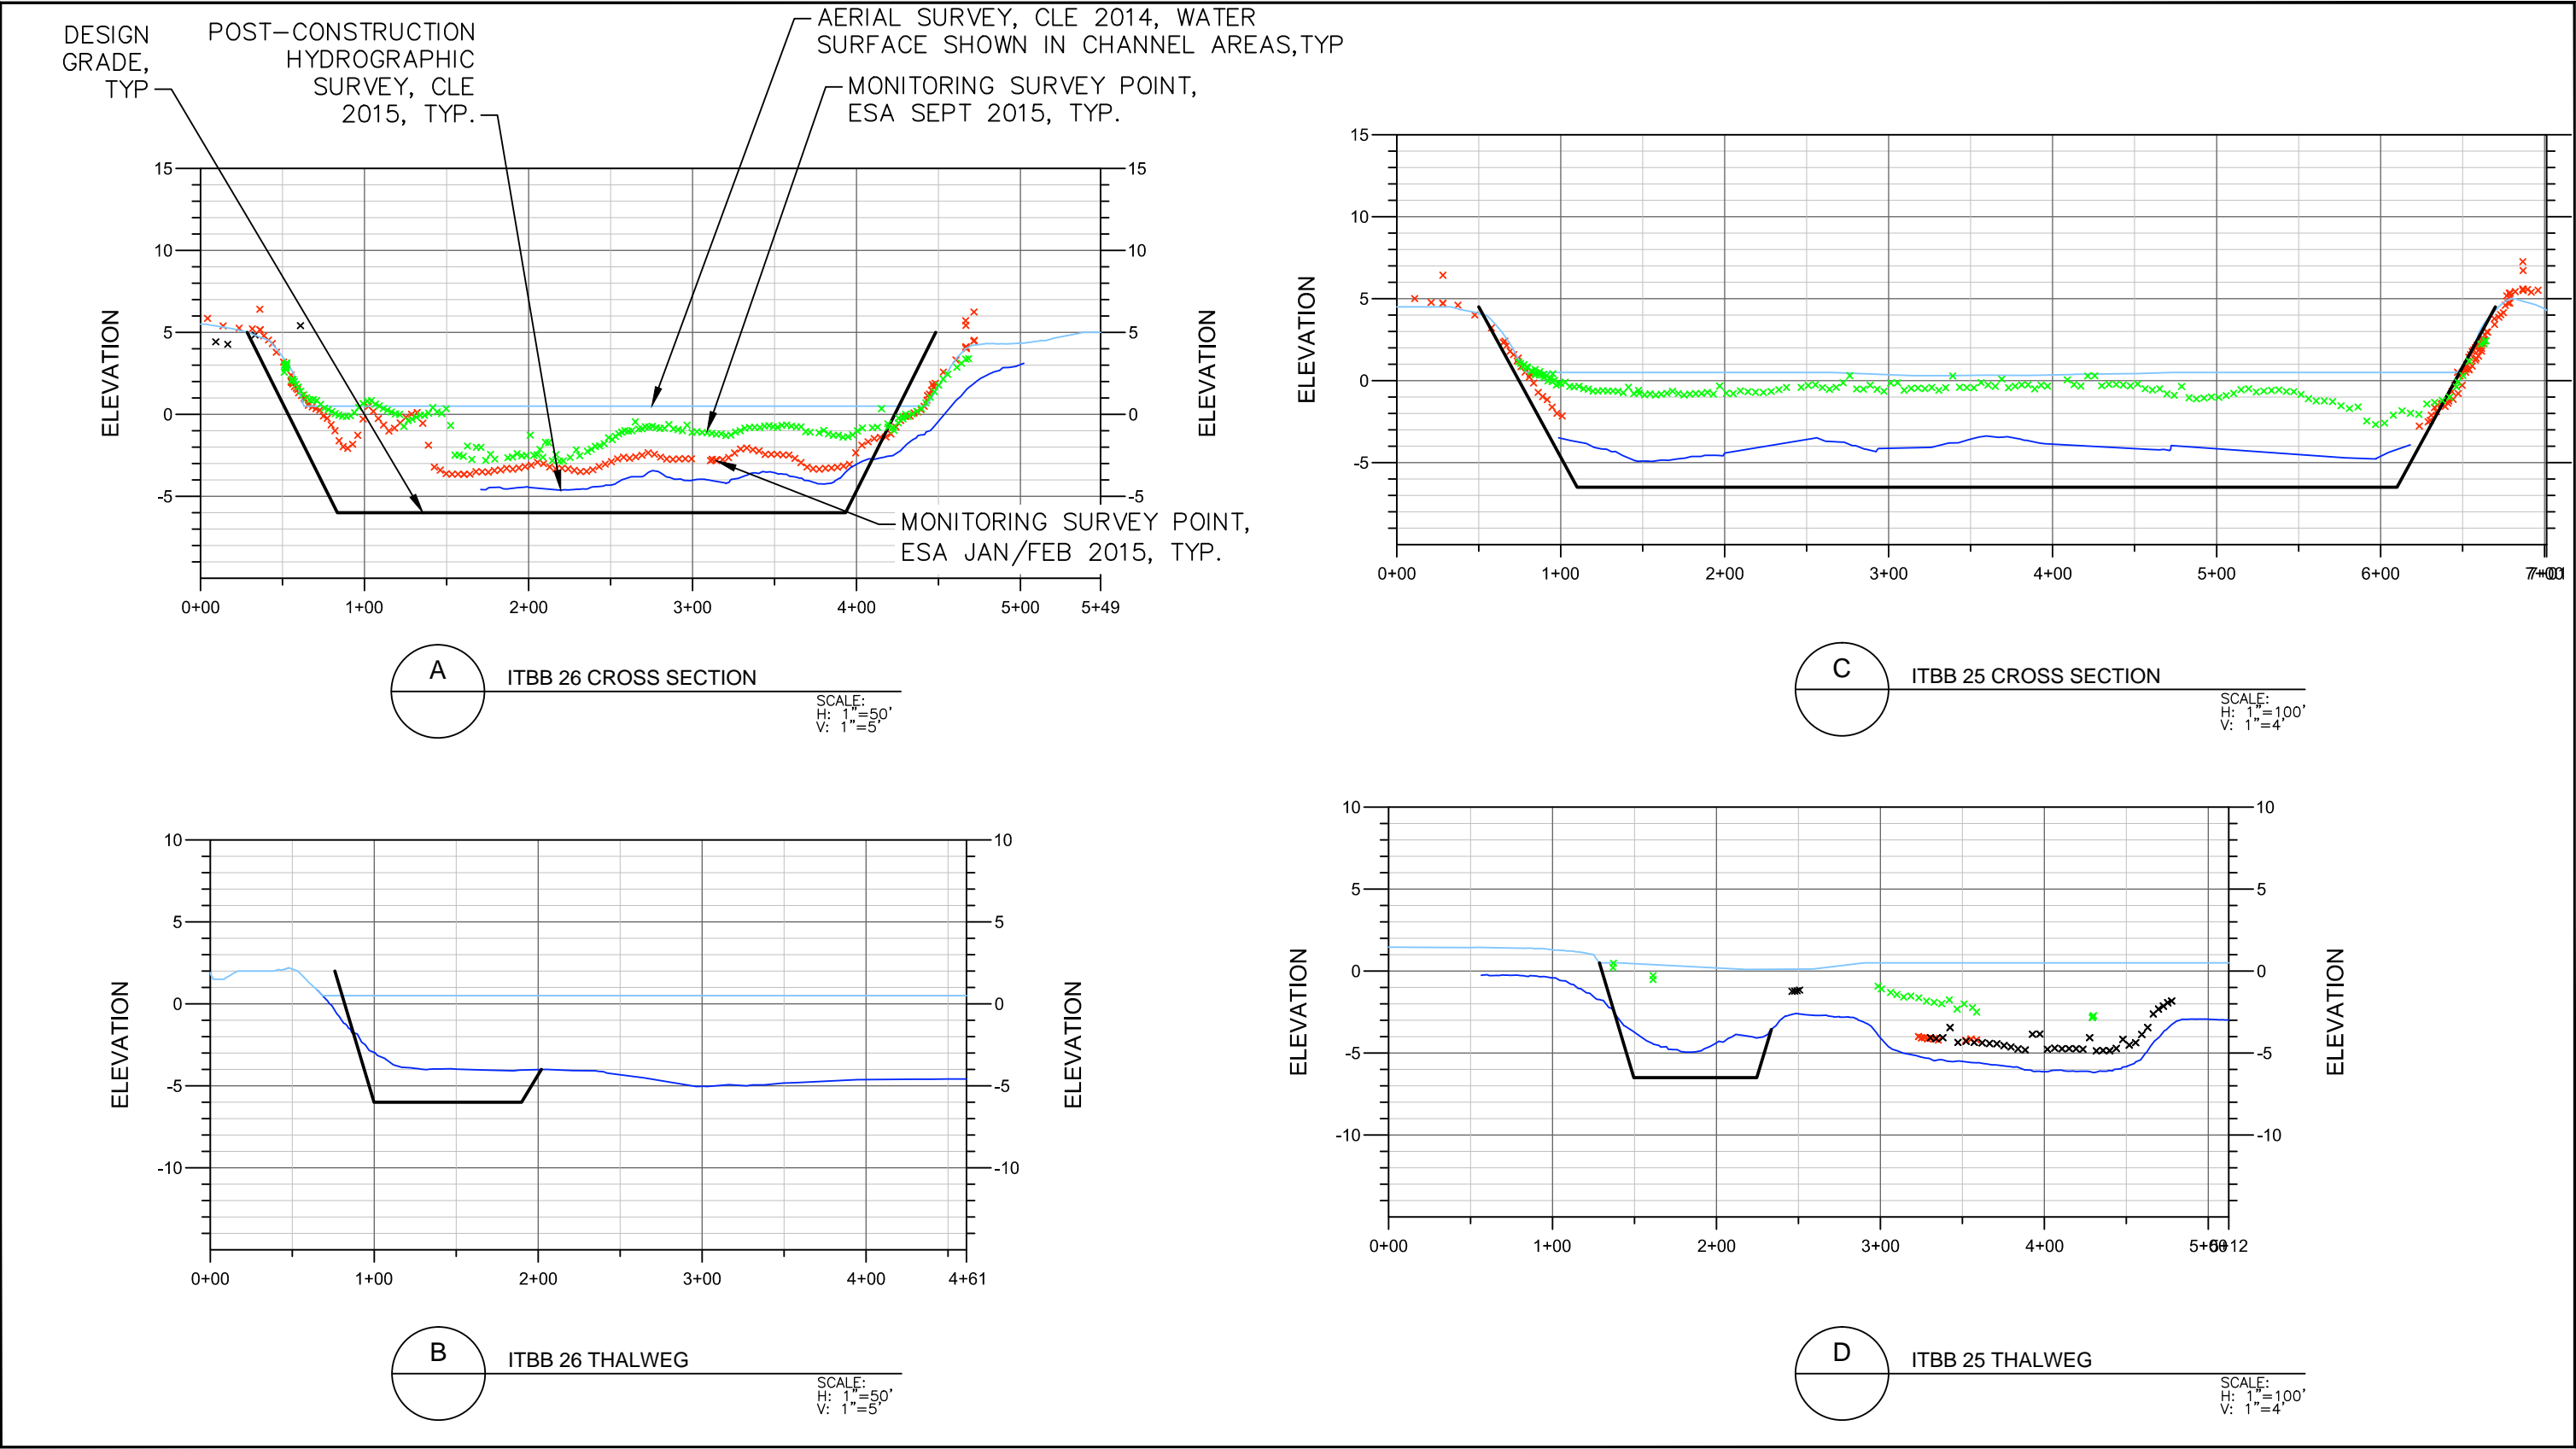
FIGURE 18

Figure 18 shows a plan view of ITBB 25 and 26, showing the location of the available survey datasets at these two breaches, including the CLE Hydrographic Survey from early 2015 (shown as contours) and the ESA Monitoring Surveys, both conducted in Jan/Feb 2015 and Sept 2015. Figure 19 shows cross sections and profiles for these two breaches. Figure 19 also shows channels ESB 25 and 26 excavated within the expanded settling basin. Figures 20 and 21 show the plan view of ITBB 14, and a cross section and profile for this breach.

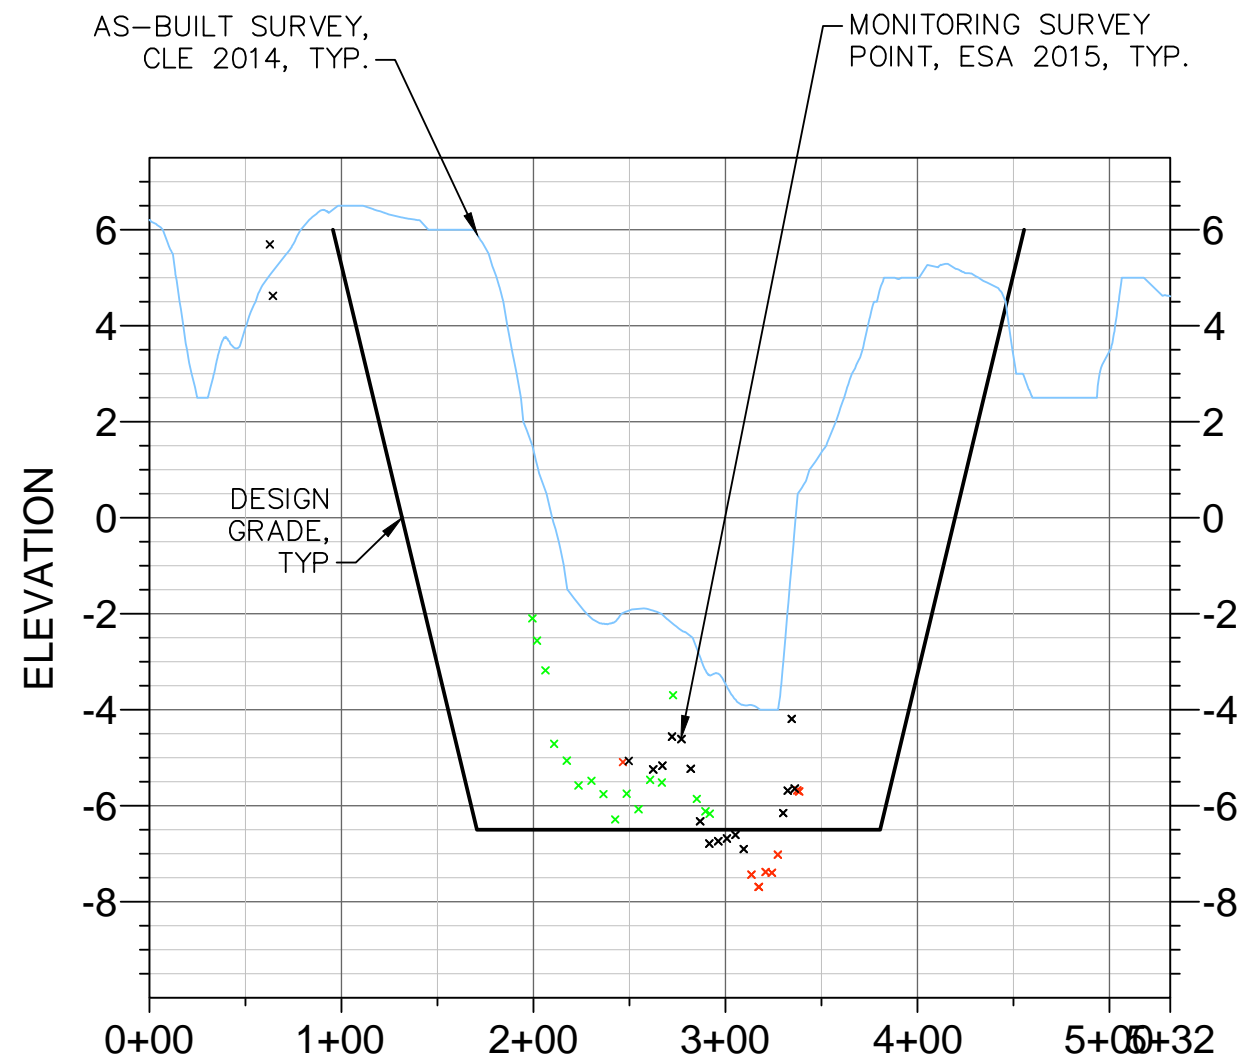
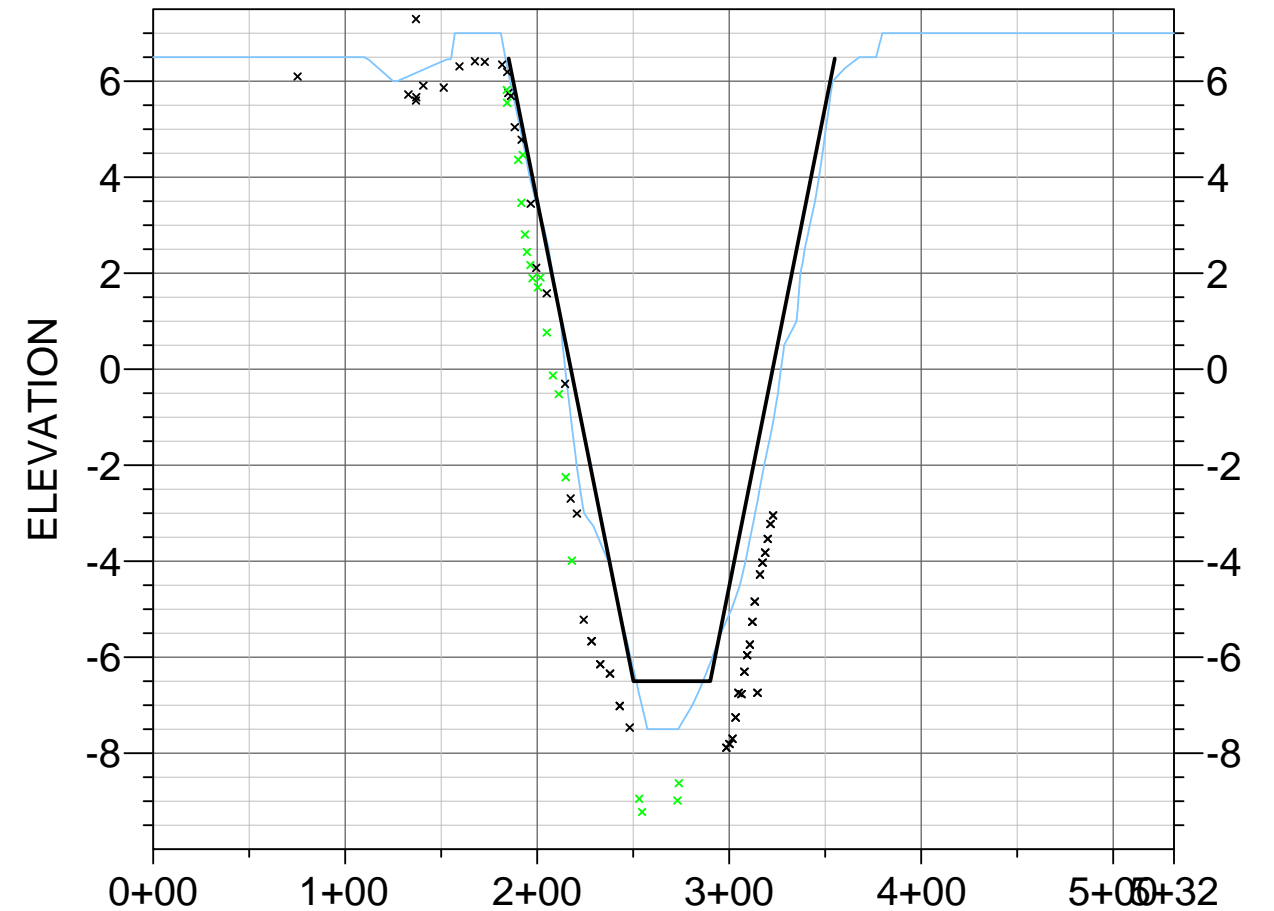
As-Built Survey Data - Outboard Levee Breach
Cross Sections 2

Figure 22 also shows the design limit of grading for the breach channel. The figure shows where the as-built grading does not extend to the limits of grading specified in the design. Specifically, the transition between the breach to the pilot channel was constructed ~40 ft inboard of the station specified in the design. This reduced excavation footprint resulted in a reduced channel width at Section C (Figure 24), with a constructed base width of about 110' vs. the 210' design width.

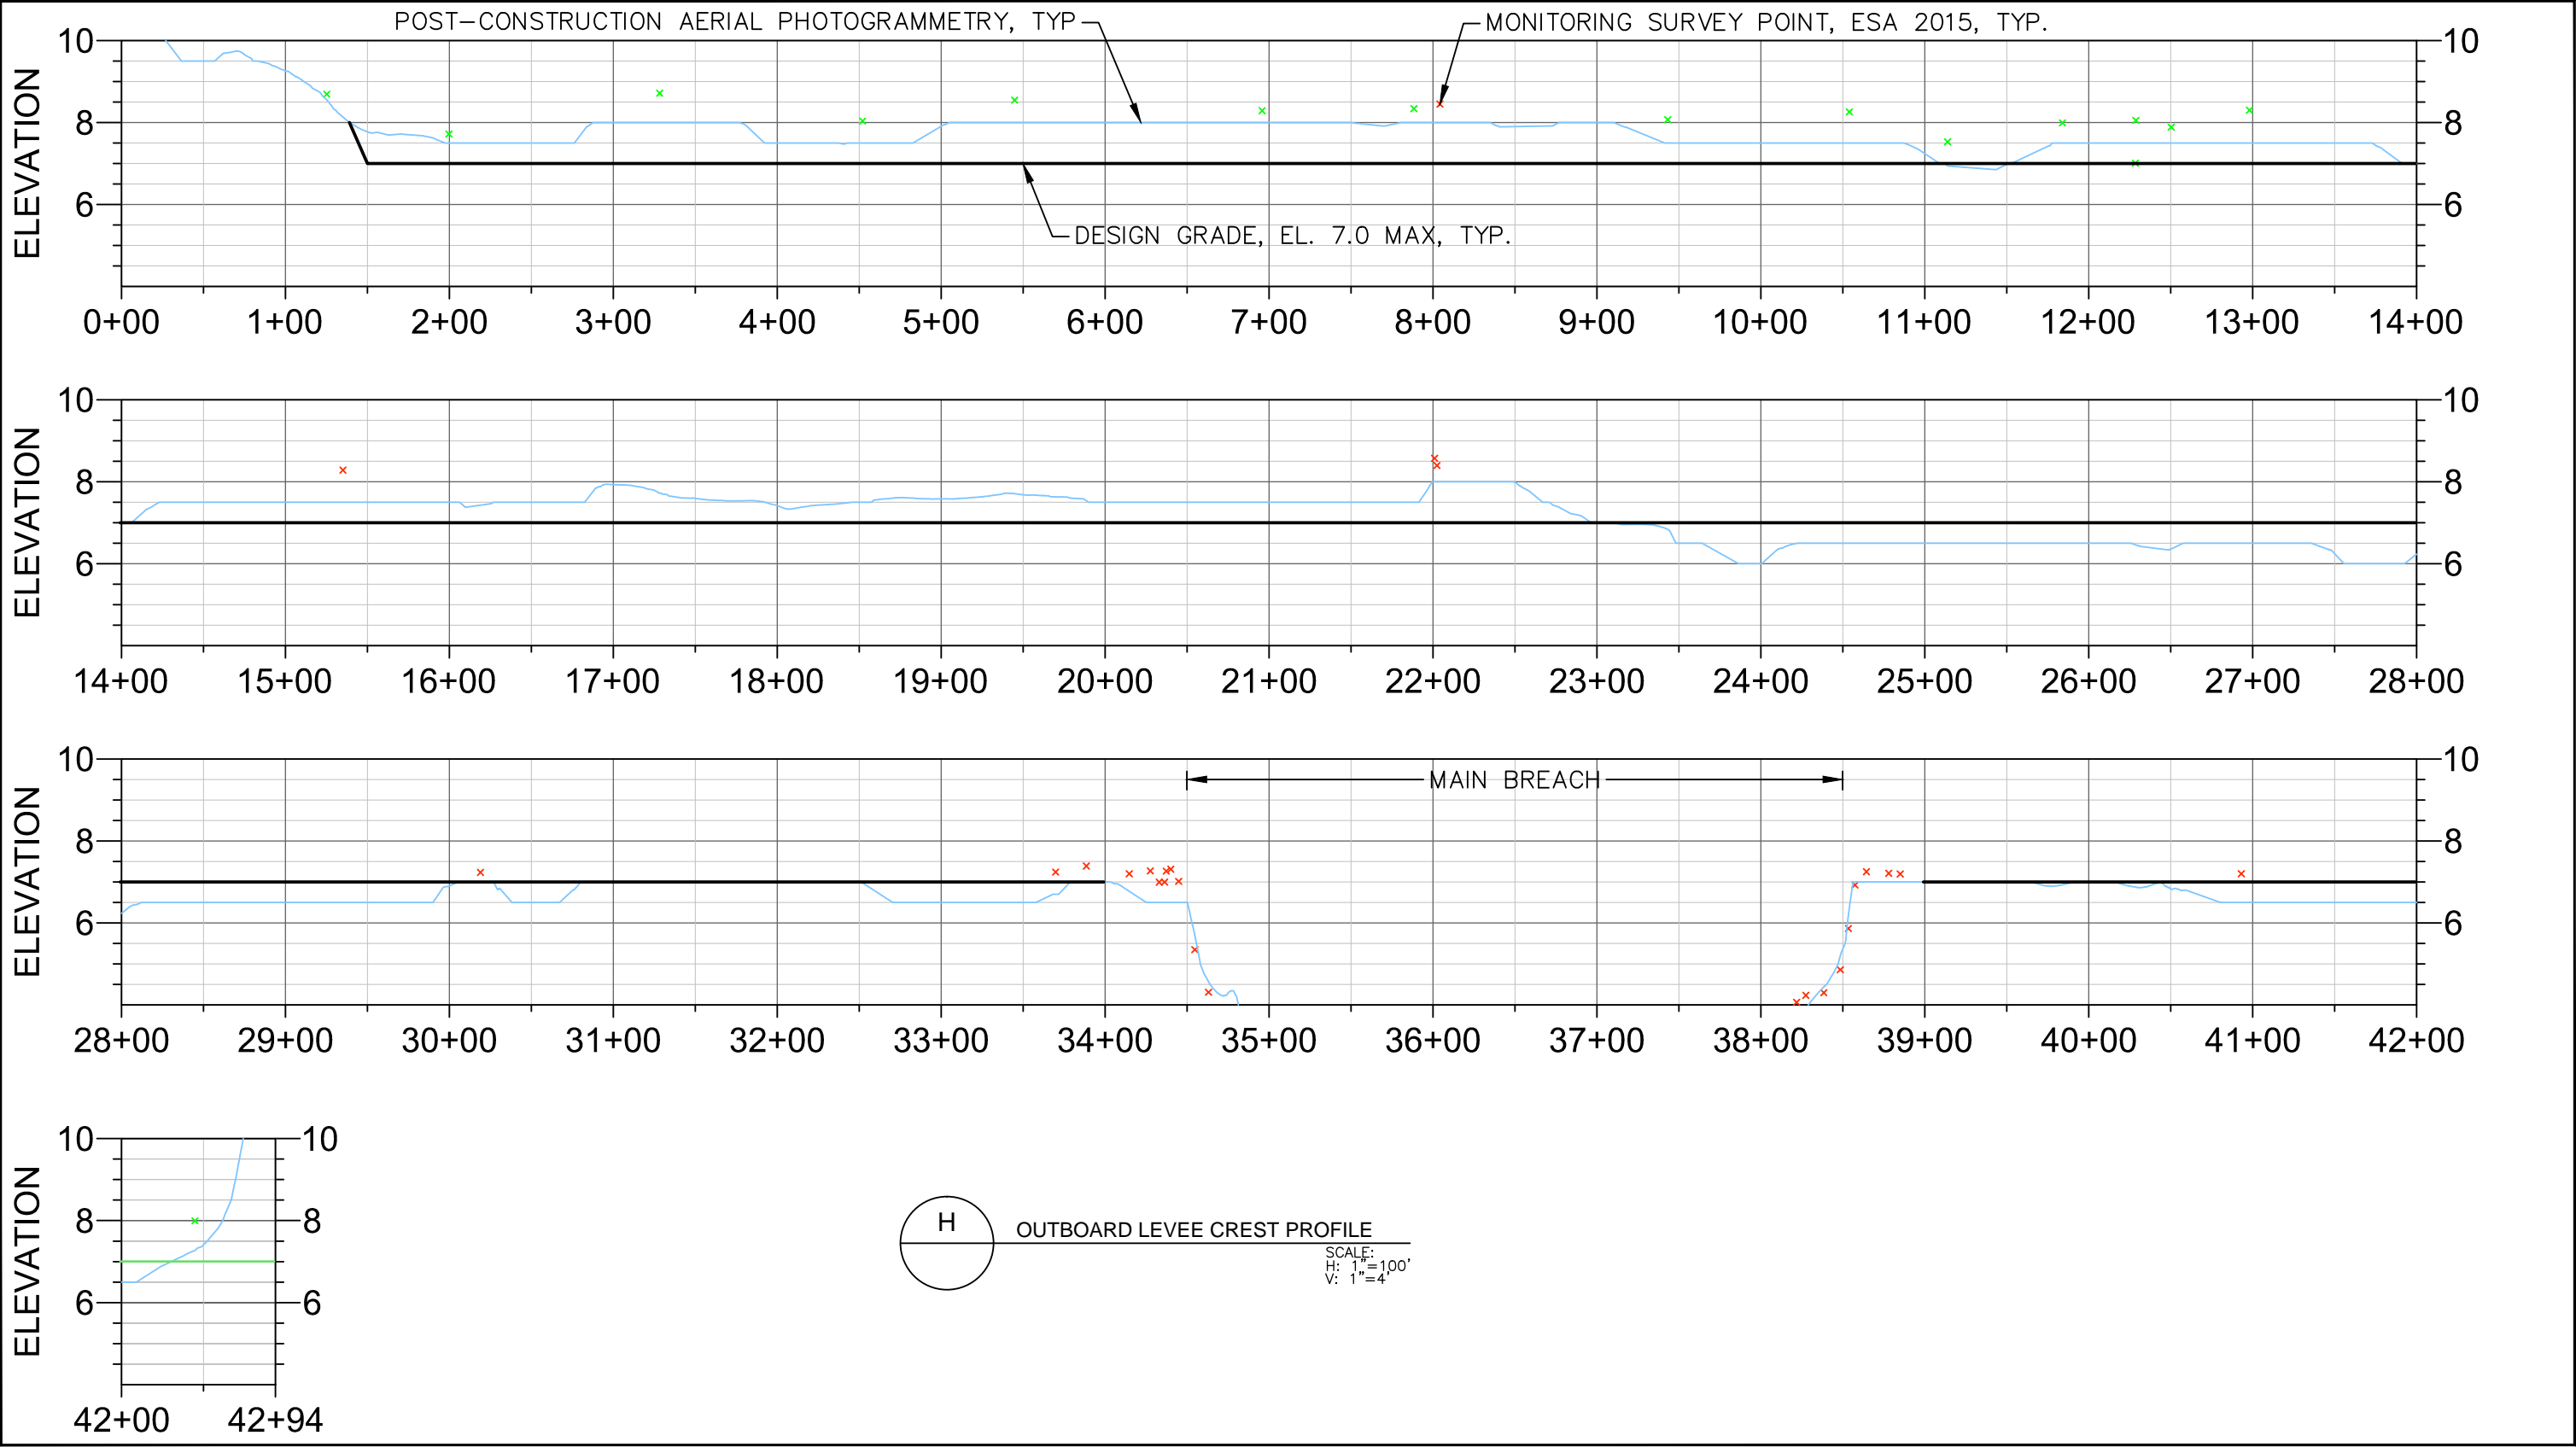
Hamilton Post-Construction Assessment
FIGURE 30
 Outboard Levee Cross Sections

The outboard levee separates the restored project area from the existing bayfront marsh. This levee was to be lowered to provide a smooth transition between the inboard and outboard marshes. The design grade of this feature sloped from ~EL 7.0 ft (@ limit of native marsh vegetation) along the outboard marsh to EL 5.1 ft at the inboard side of the levee. The as-built crest elevation was found to be considerably higher than the design grade, reaching elevations up to 8.72 ft, and consistently exceeding EL 8.0 ft for long stretches. Figure 29 shows a plan

view of the outboard levee, including the location of spot elevations collected by ESA. Figure 30 shows several cross sections cut along the length of the outboard levee, showing as-built grades captured by the aerial photogrammetry as well as the design grade. Figure 31 shows a profile along the centerline of the outboard levee, showing as-built grades captured by the aerial photogrammetry, as well as high points captured in the ESA monitoring survey. This figure also highlights the EL 7.0 ft, the maximum allowed elevation of the lowered levee.
